Case Studies of Rehabilitation, Repair, Retrofitting, and Strengthening of Structures

Structural Engineering Documents

This monograph provides case studies of structural rehabilitation, repair, rehabilitation, strengthening, and upgrading of structures, which might be encompassed - in short - by the convenient umbrella terms “Conservation / Maintenance / Preservation / Upgrading of Existing Structures”. Other umbrella terms for the activities related to maintaining and/or improving the structural performance of existing structures include: Restoration, Structural Renovation, Remedial actions. Rehabilitation and retrofit are sometimes used also as umbrella/generic terms. Terminology is discussed in more detail in the “Introduction”.

The selected studies presented in this IABSE SED (Structural Engineering Document) cover a variety of structural types from different countries. SED 12 has been prepared as a joint activity between two IABSE Working Commissions WC3: *Concrete Structures*, and WC4 (formerly WC8): *Operation, Maintenance and Repair of Structures*.

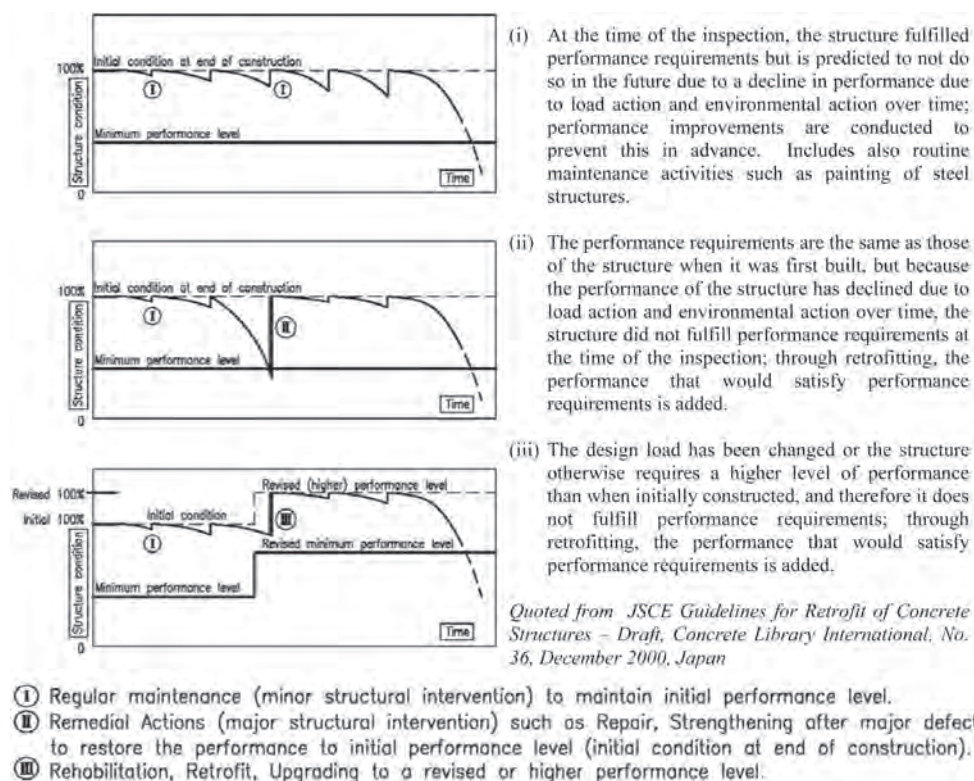
Fig. 1.1: Schematic Presentation of Typical Inspection/Maintenance/Repair/Upgrading cycles over the service life of a structure. (Based on: EN 1504-9:2008 Products and systems for protection and repair of concrete structures. Part9: Principles for the use of products and systems, Figure A.2, page 20)

Activities on Conservation, Maintenance, Preservation, Upgrading, Rehabilitation, renovation, Retrofit, and routine/preventive maintenance of structures might be presented schematically as in the following graph:

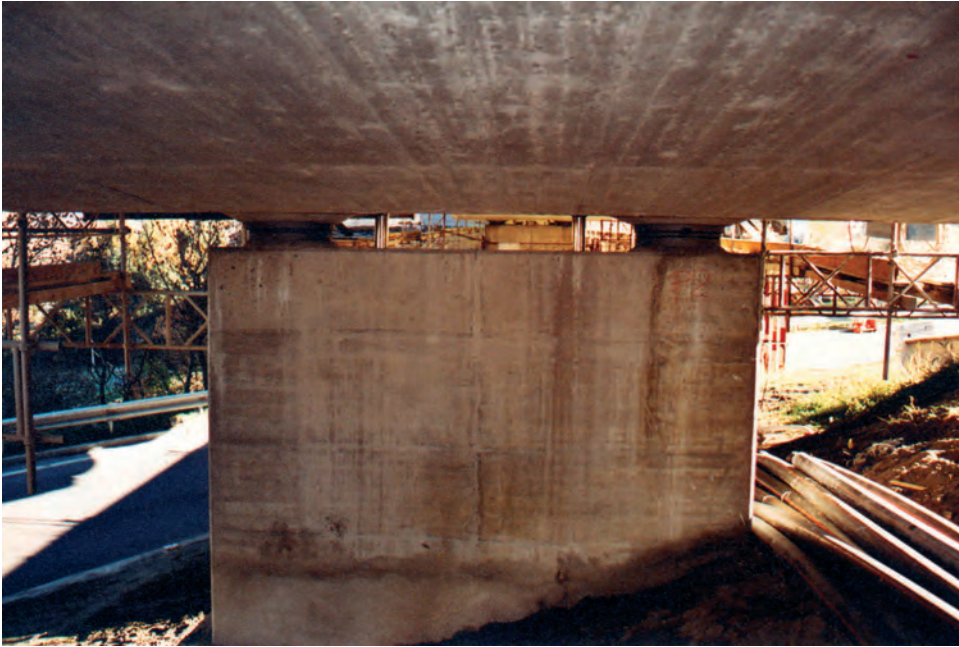
Fig. 2.5: Rustproof steel bars $D = 80$ mm on the pier heads [1]

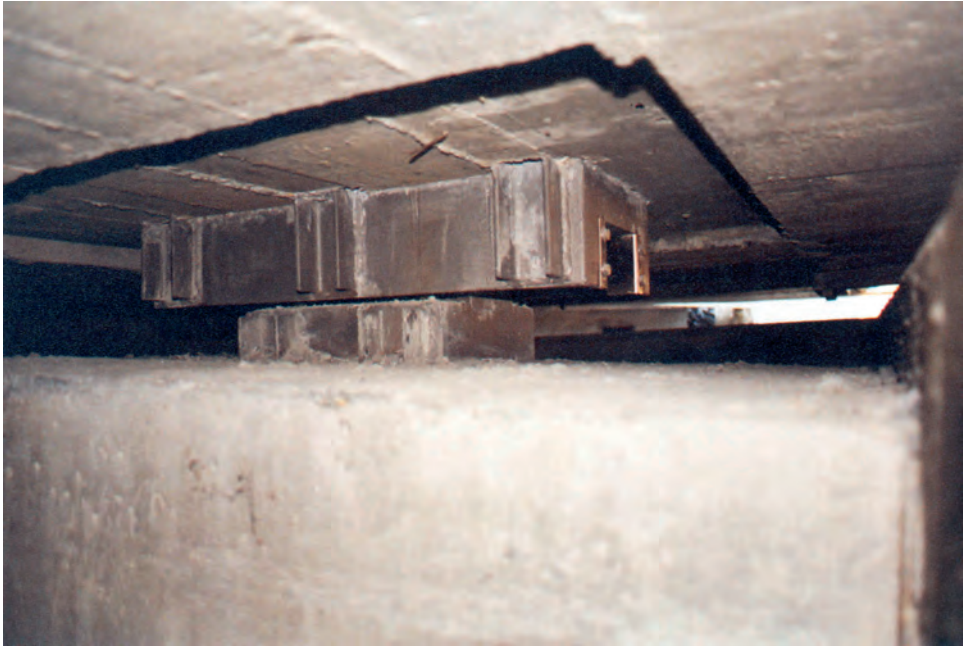
Fig. 2.6: Fixed bearings at the abutments were replaced by the unidirectional sliding bearings

A safety check of the existing bearing system, under the concurrent Swiss code of structural design (SIA 160 valid in 2001), has shown that fixed bearings at the abutments will collapse under the action of the higher seismic loads. After the collapse of fixed bearings, the

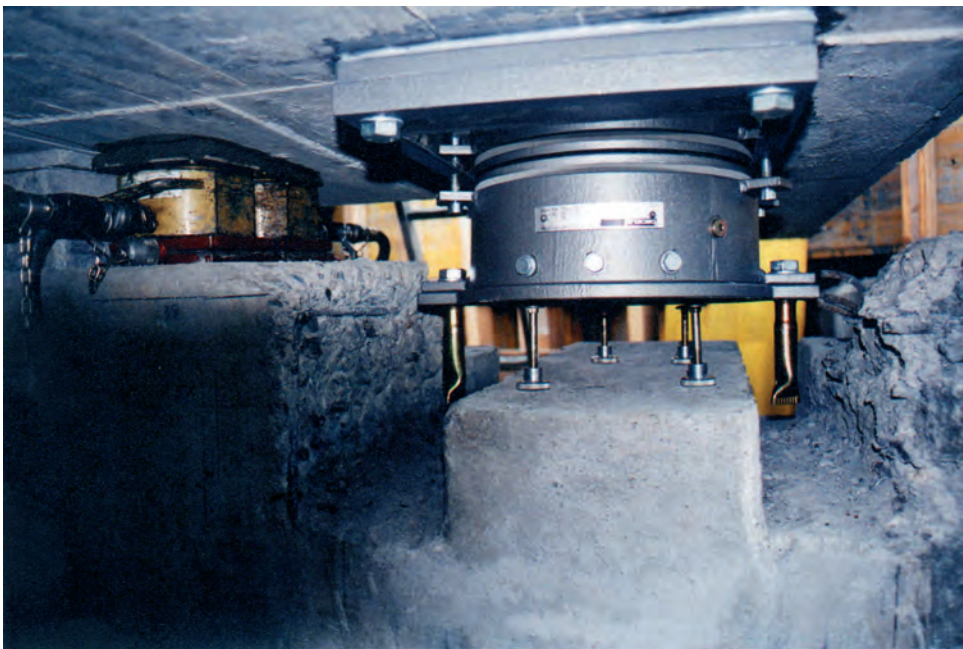
Fig. 2.7: Uplifting of the bridge during replacement of the abutment bearings [1]

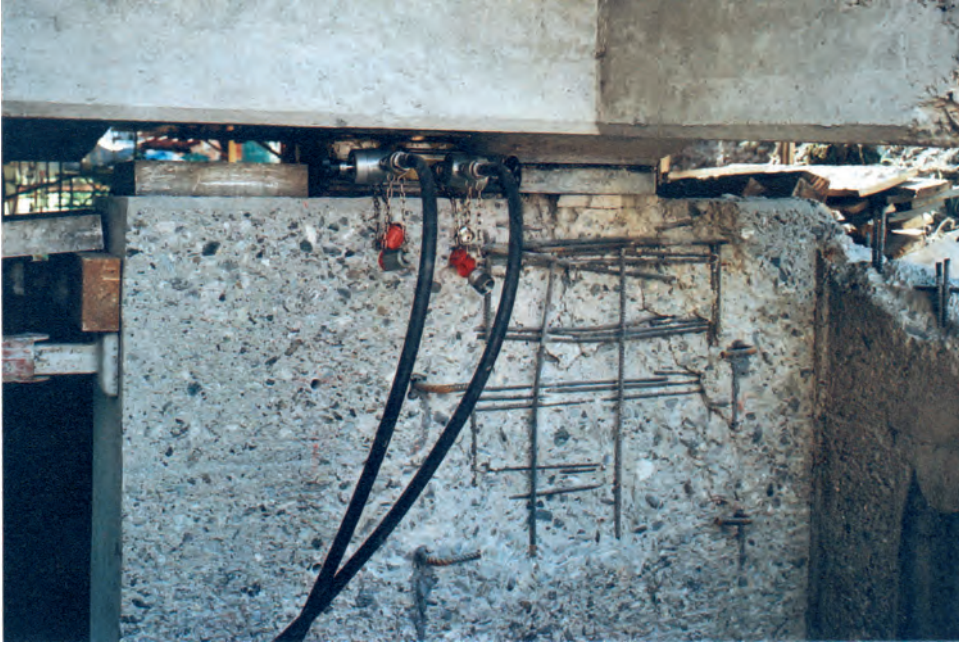
Fig. 2.8: Enlarging and reinforcement of the abutment walls [1]

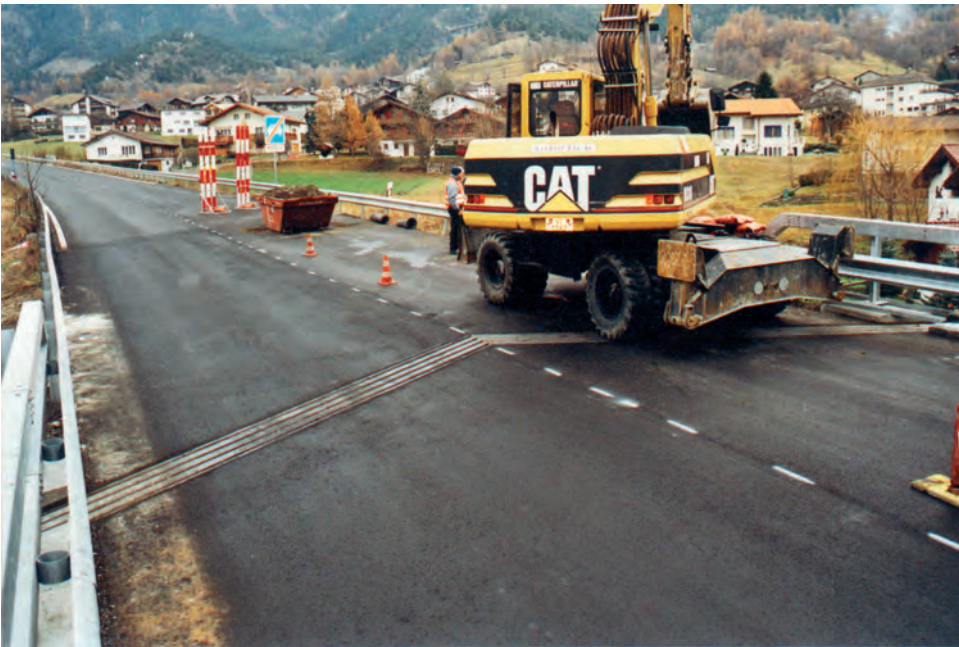
Fig. 2.9: Joints at the bridge ends have been replaced by larger ones with V-shape [1]

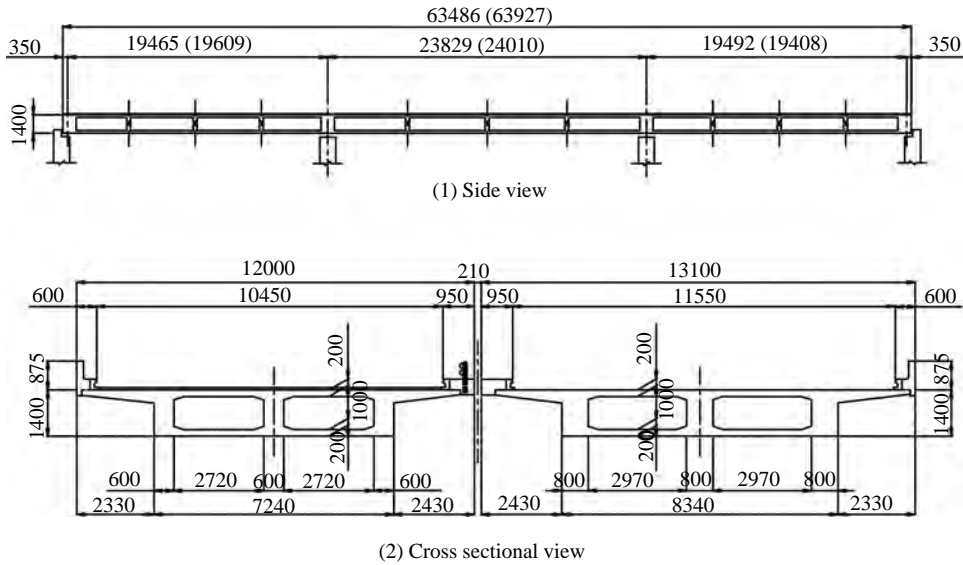
Fig. 3.1: General view of the Chofu Bridge (unit:mm)

The Chofu Bridge of Chuo Highway is a three-span continuous reinforced concrete (RC) box girder bridge that was constructed 28 years ago and is located in the western part of Tokyo, Japan. The general view of the bridge is indicated in *Fig. 3.1*. The bridge condition had deteriorated through 28 years of heavy traffic loading and had many cracks on the underside of the main girders.

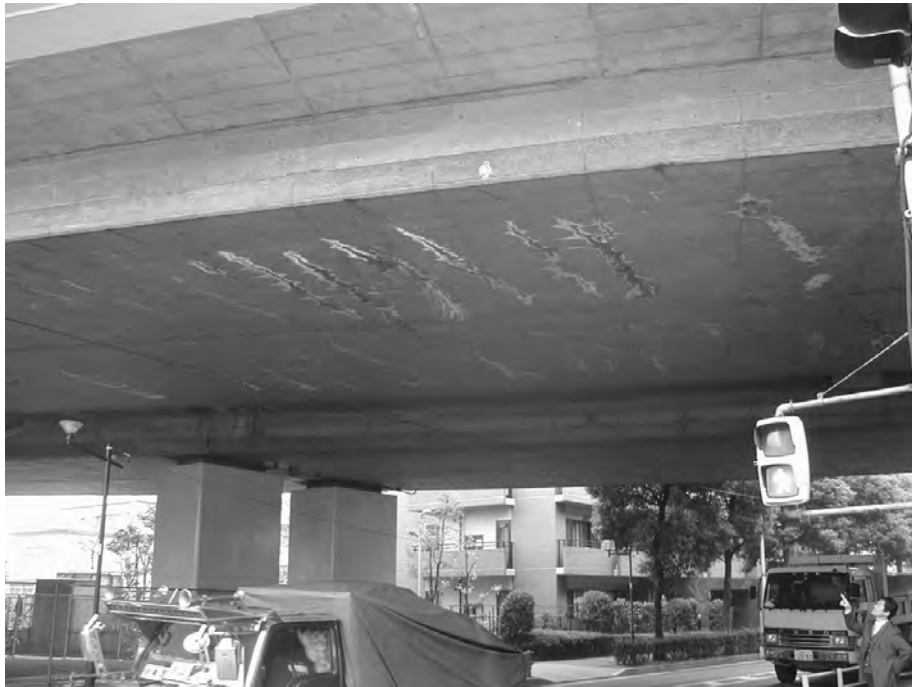
Fig. 3.2: State of damages

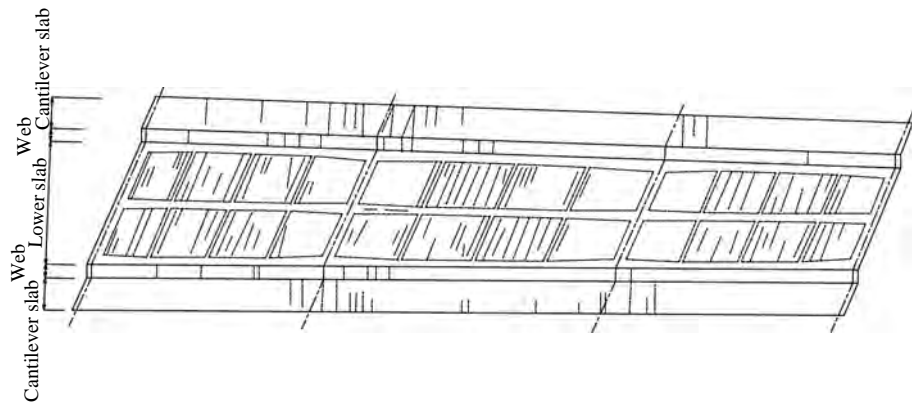
Fig. 3.3: Crack pattern diagram

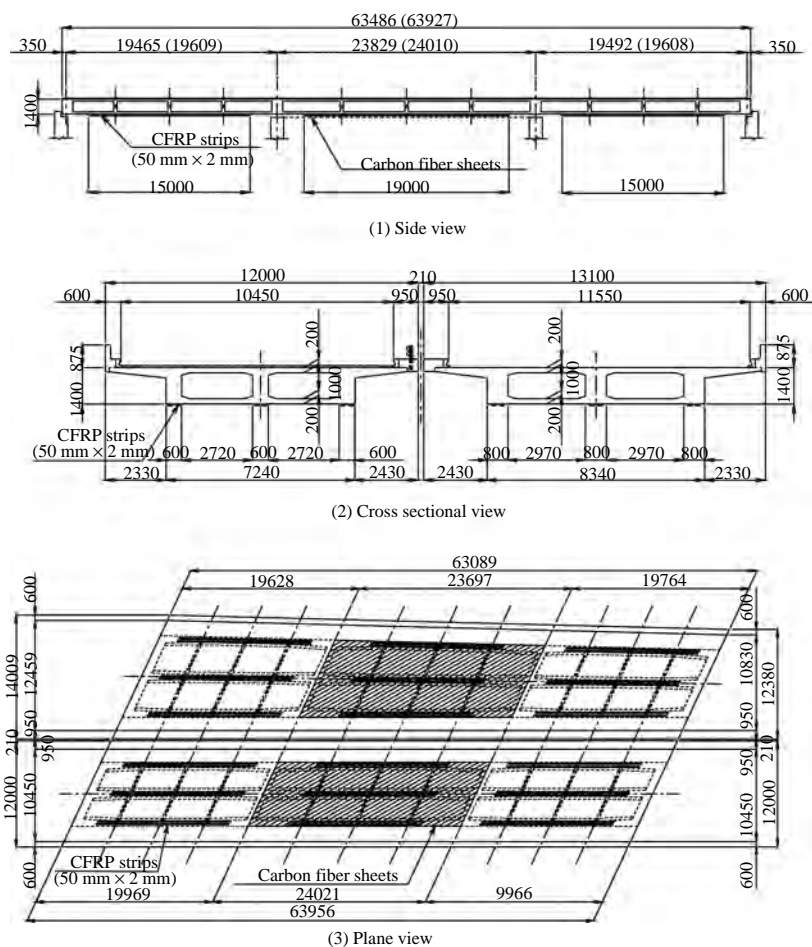
Fig. 3.5: Allocation of CFRP strips and CFRP sheets (unit:mm)

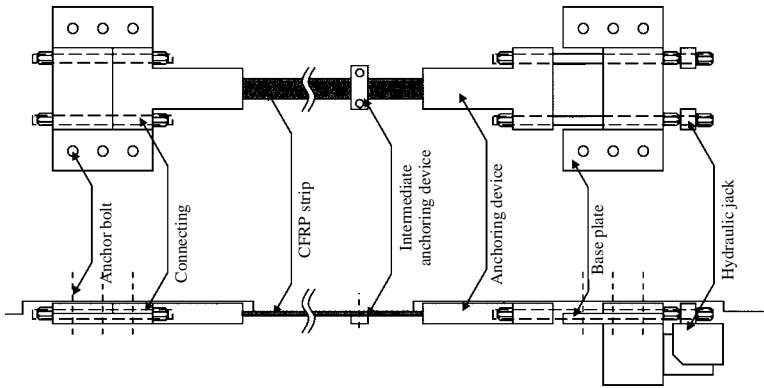
Fig. 3.6: Tensioning system

The tensioned CFRP strip method consists of a tension plate, base plates, and intermediate anchoring devices. The tension plate is a CFRP strip that has anchoring devices at both ends. Base plates are steel frames that are attached to the concrete surface for anchoring the tension plate and for holding the specially modified hydraulic jack. Intermediate anchoring devices are simple stainless steel plates and anchor bolt (shown in Fig. 3.6). In order to prevent the CFRP strip from damage, a Teflon plate is inserted between the stainless plate and the CFRP strip. The CFRP strip is 2 mm thick and 50 mm wide. Each end of the strip is inserted into an anchoring device that is made of steel. Both ends are embedded and anchored by an expansive paste. This anchoring method is effective to reduce the stress concentration of CFRP strip at the anchoring device and full advantage of the high strength of CFRP can be taken [5]. The CFRP strip is made up of high strength carbon fibres and thermosetting resin, and fabricated using a pultrusion method. Characteristics of the CFRP strip are shown in Table 3.1. Any particular fire protection such as mortar coating was not used because in case of fire the

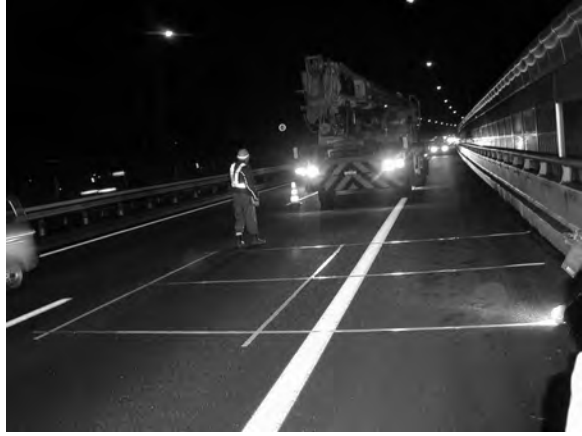
Fig. 3.9: 45 t weight vehicle

A 45 t weight vehicle (shown in Fig. 3.9) was placed statically at three different positions, as shown in Fig. 3.10. The stress in the longitudinal reinforcing bars, concrete crack width and depth, and deflection of the main girder were measured during the load testing, which was conducted both before and after the tensioned CFRP strip was applied. Crack width and depth were measured using displacement transducer and ultrasonic sensors, respectively. The 450 kN (45 t weight) load corresponds to 26.3% of the design live load at the centre of the side span. Measurement points are shown in Fig. 3.11.

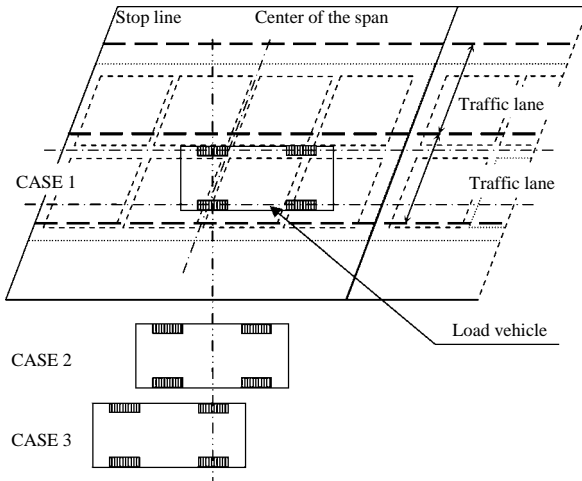
Fig. 3.10: Loading points

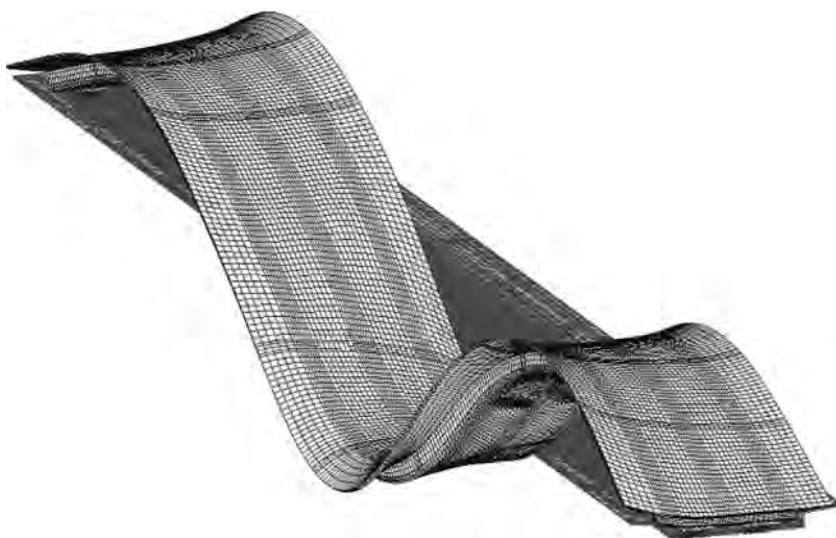
An eigenvalue analysis was conducted with a finite element method (FEM), assuming that there is no cracking in the concrete, as shown in Fig. 3.13. The natural frequency of the primary mode was determined to be 5.393 Hz, and this value was found to be very close to the measured value 5.2 Hz after strengthening application. This result implies that the rigidity of the main girder was improved by this strengthening method.

Fig. 3.13: Primary mode (FEM)

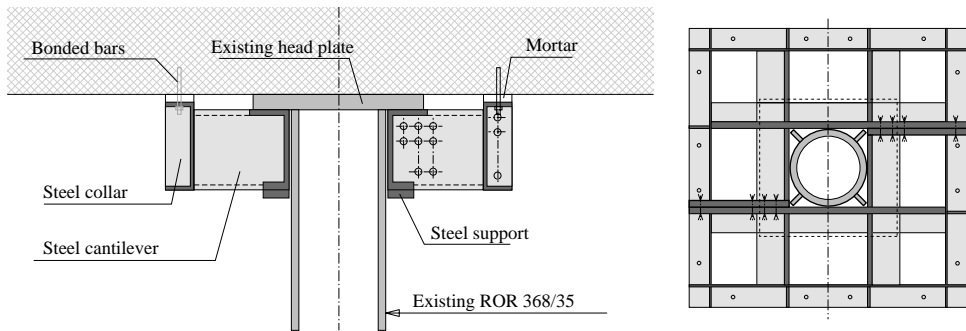
Despite the improvements, several details could not be solved to full satisfaction. Almost 60 collars would have to be produced and mounted. The weight of 650 kg per element would hinder the execution on site and the total amount of steel leads to inappropriate cost. Additionally, it was uncertain what amount of load could be carried at the expected small deformation due to the stiff behaviour of the concrete slab of 600 mm thickness on a span of only 8.44–9.00 m. Possibilities to prestress or preload the steel collars were evaluated to

Fig. 4.3: Considered steel collar

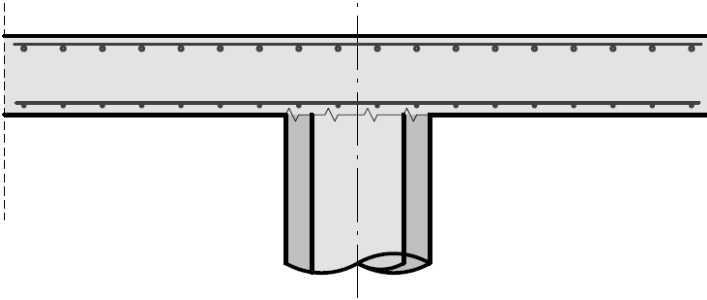
If the resistance of the columns is insufficient for the given reactions, the enlargement of the columns (*Fig. 4.5*) is a suitable strengthening method. The column can be encased in two half shells of steel or be enlarged with cast-in-place reinforced concrete. Precast concrete elements are a possibility as well. Usually, the head would be widened with regard to the column. Thus, a higher punching shear resistance is achieved with the new column part supporting at least live loads. Because the columns at the Station Square in Berne have no resistance deficiency, this method was not suitable.

Fig. 4.5: Exemplary enlarged column [7]

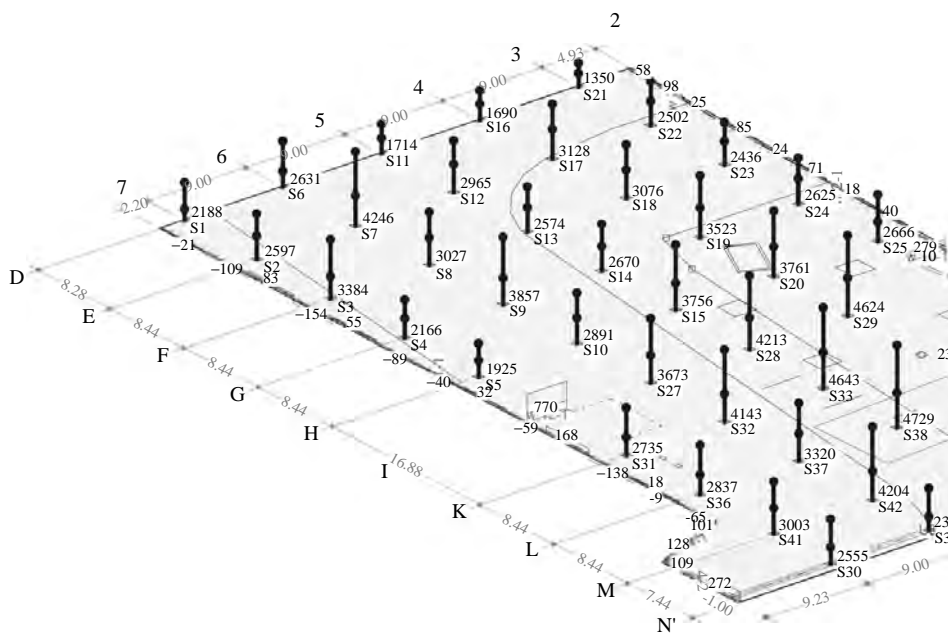
Fig. 4.11: Factored column reactions

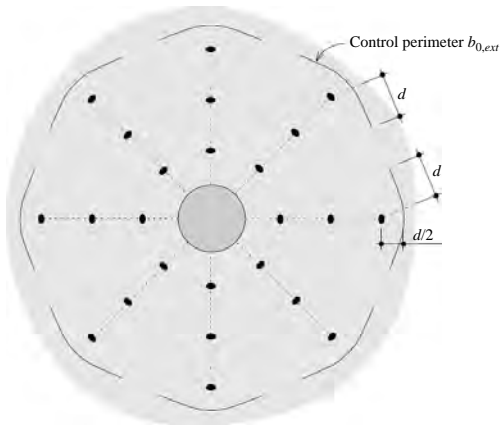
The reinforced area must be such that the verification for the outer control perimeter guarantees sufficient punching shear resistance outside the reinforced area according to the applied structural concrete code. It should be mentioned that the static height is reduced if the lower anchor head is embedded in the concrete slab. Figure 4.14 shows the definition of the outer control perimeter. It can be increased with intermediate anchors in the outermost circle.

Fig. 4.14: Outer control perimeter [9]

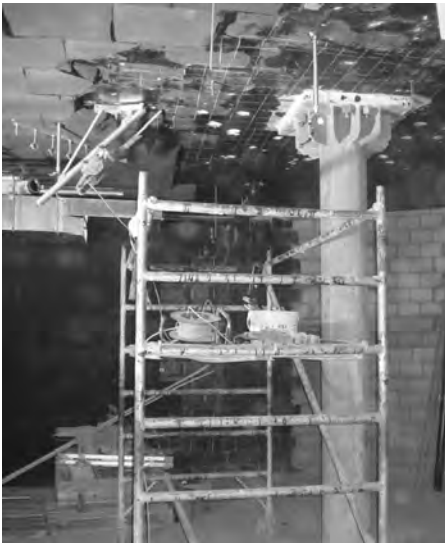
Fig. 4.21: Mobile scaffold and hammer drill anchored to the slab

The construction process and the equipment are illustrated in *Figs. 4.21–4.25*. The selected strengthening method allows independent construction on the upper and lower sides of the concrete slab. Only the anchoring of the upper tensile reinforcement layer has to be executed from the upper side. The power drill is either mounted on a one-footed trestle or anchored to the slab.

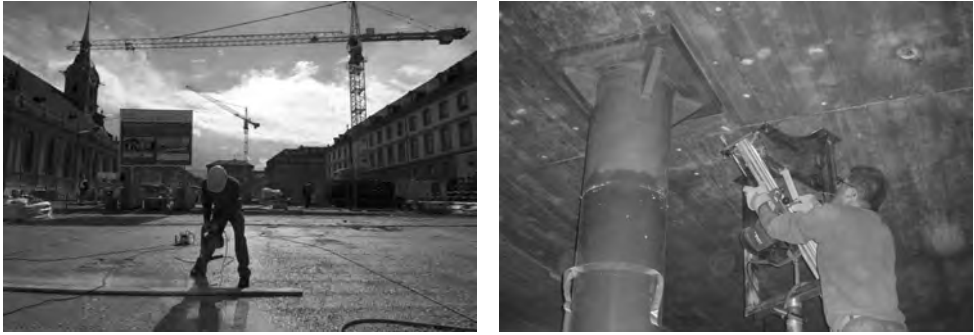
Fig. 4.22: Drilling for anchoring of upper tensile reinforcement and for punching shear reinforcement

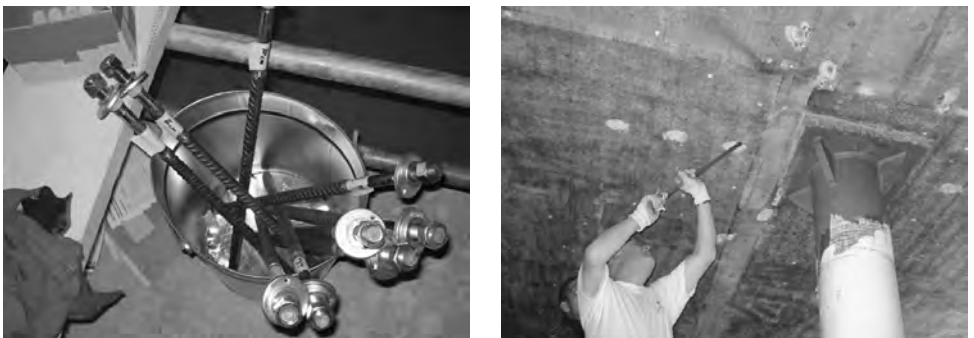
The hammer drilled holes are injected with adhesive mortar. The described strengthening anchors are set into the holes subsequently. The lower anchor head is installed after hardening of the adhesive mortar. To ensure a slip-free anchorage, the interface between washer and concrete is injected with adhesive mortar through the washer. Finally, the enlarged lower part of the hole is filled with fire protection mortar. The anchor head is thus completely embedded and not visible.

Fig. 4.24: Adjusted HZA-P anchors to the individual hole depth and installing in the hole

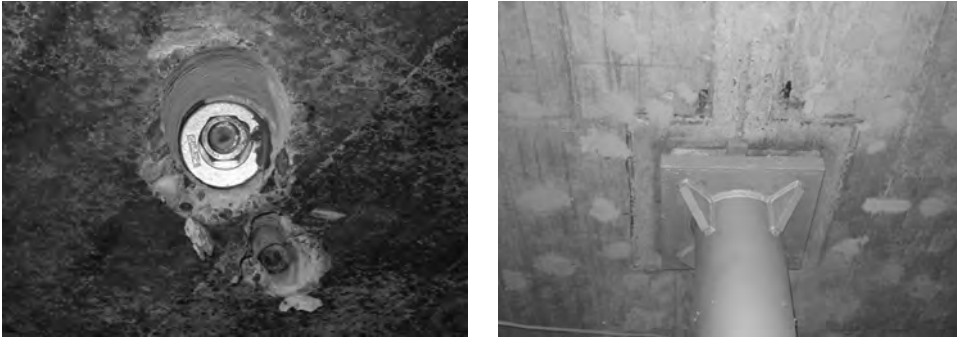
Because of the decreasing resistance with holes not reaching the required length, it is important to ensure continuous construction inspection. The actual depth of the hole should be noted next to it on the slab. The anchors have to be shortened to the respective length of the hole they are installed in. If it is not possible to reach the requested minimum depth, the unfinished hole has to be filled with adhesive mortar and a short piece of reinforcement bar. For each

Fig. 4.25: Embedded and injected anchor head next to an unfinished hole and concrete surface after strengthening

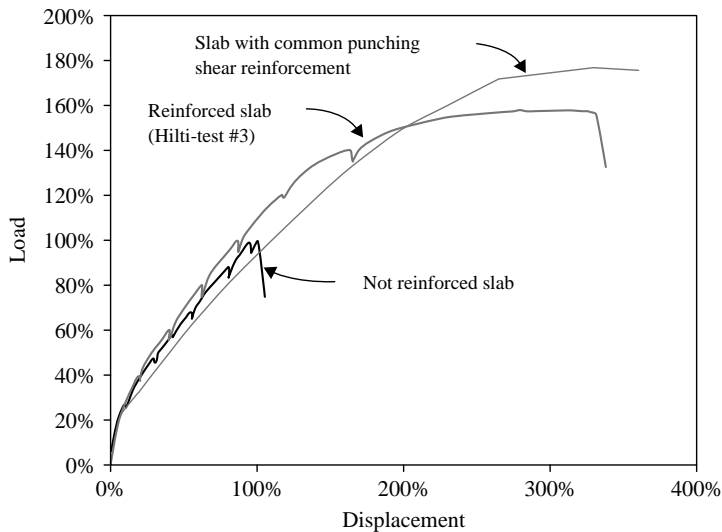
Fig. 4.27: Load displacement curves (translated from Ref. [7])

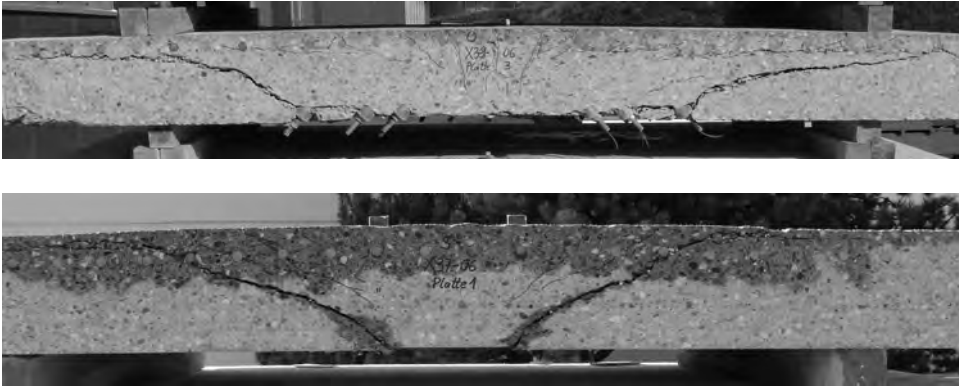
no. 3), and a slab with common cast-in-place punching shear reinforcement. Figure 4.28 shows the failure patterns for concrete slabs with and without post-installed punching shear reinforcement. The Hilti internal test reports will not be published, for more details see Refs. [8, 11].

Fig. 4.28: Failure patterns with and without post-installed punching shear reinforcement [11]

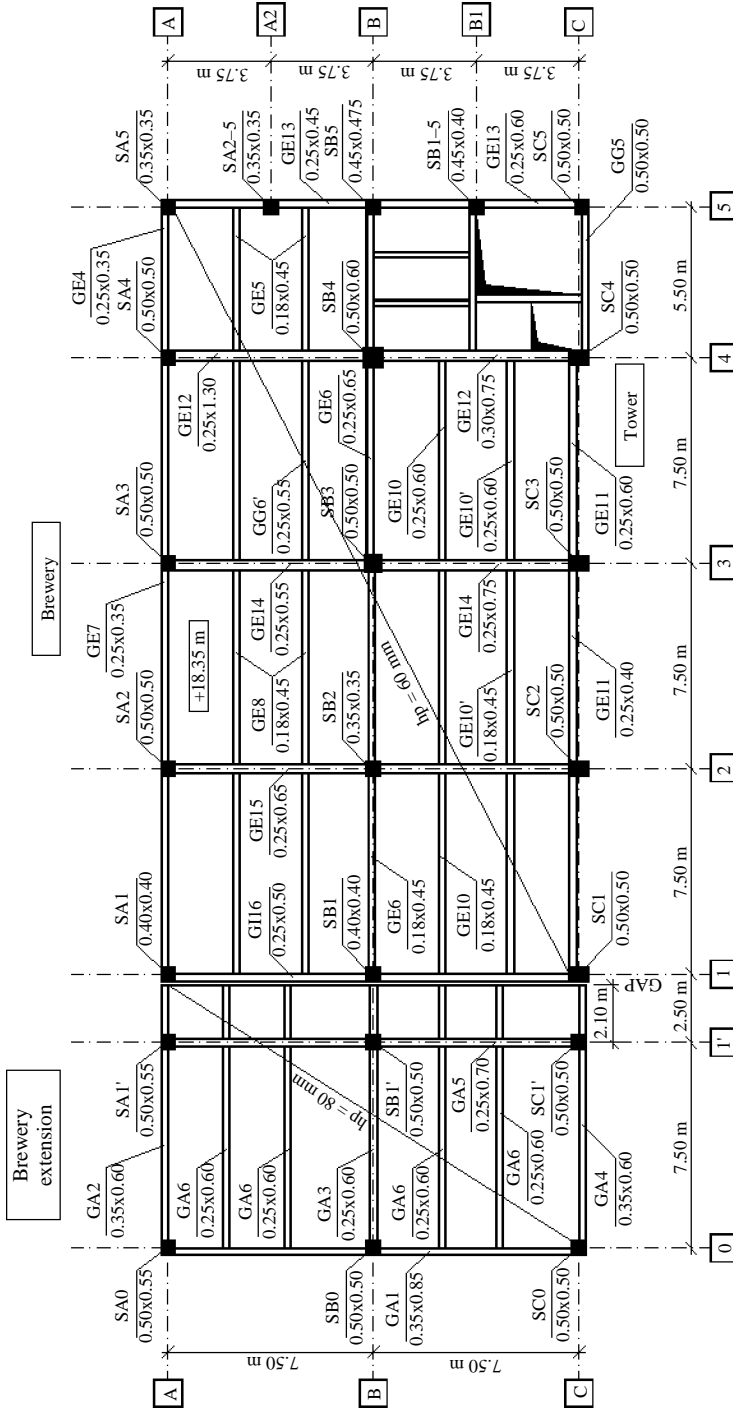
Fig. 5.4: The Timisoreana Brewery—framing plan, level +18.40 m

The reinforced concrete monolithic floors are made of secondary and main beams and a one way reinforced slab, as shown in *Fig. 5.4*.

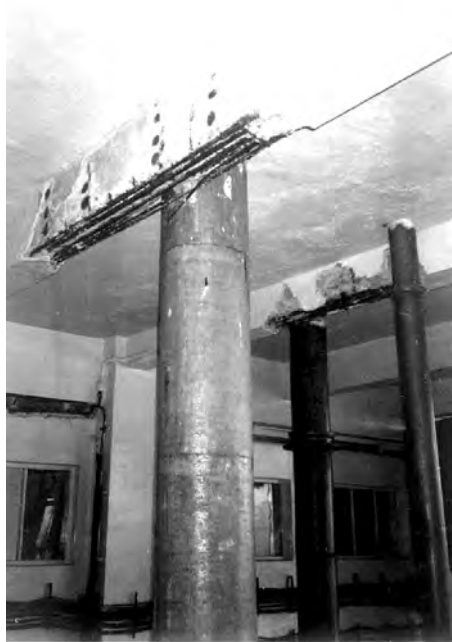
The main problems were local damage of some structural elements and inadequate reinforcement of columns and beams at seismic actions. Local damage was noticed and assessed at slabs, main girders, secondary beams, and columns. The damage consisted of concrete carbonation:

Fig. 5.5: Damage of secondary beams

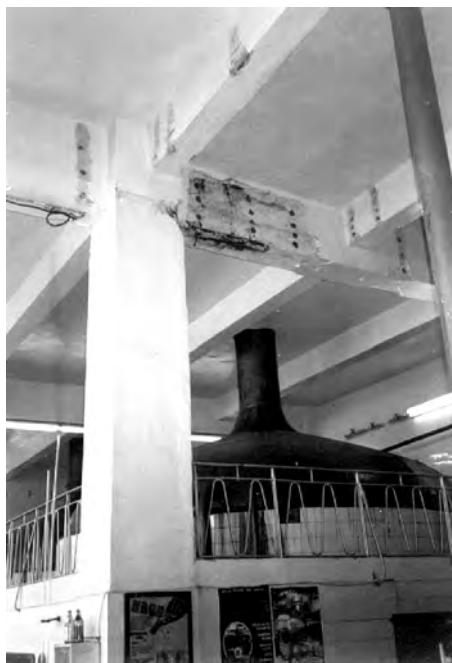
Fig. 5.6: Damage of main beams

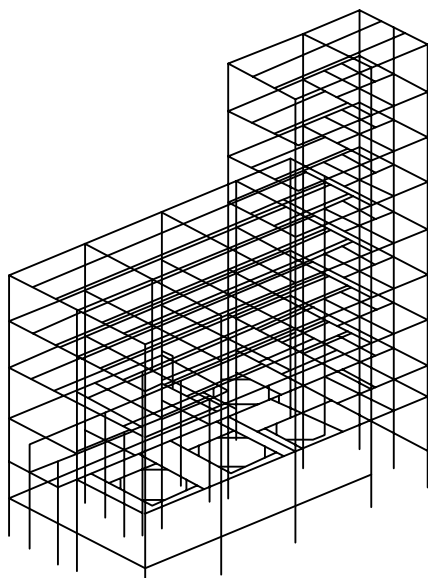
Fig. 5.9: Spatial structure analysed by FEM

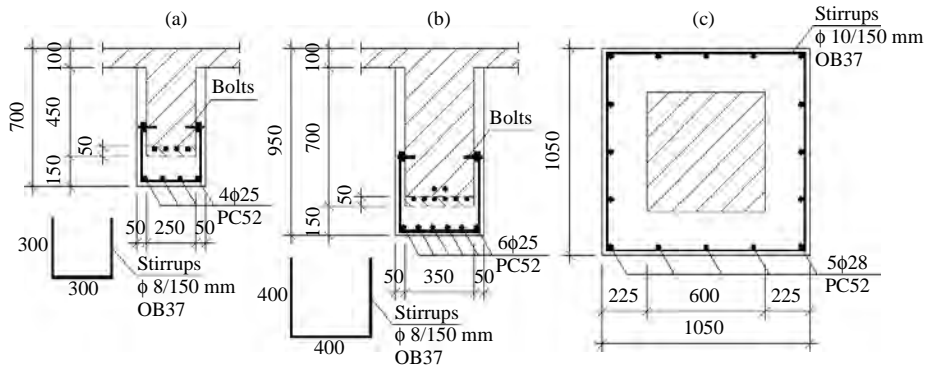
The rehabilitation of the reinforced concrete structure adopted and performed in 1999 for both types of damages consisted of jacketing with reinforced concrete of deteriorated beams, one column and its foundation. The main girders and secondary beams were strengthened by coating with reinforced concrete. New 4ϕ 25 mm reinforcement bars for each secondary beam and 6ϕ 25 mm reinforcement bars for main girder were placed at 150 mm from the bottom side of the beams with new stirrups $\phi 8/150$ mm (*Figs. 5.10a, b and 5.11a*). One column

Fig. 5.10: RC jacketing solutions: (a) secondary beam; (b) main girder; (c) column (Units: mm)

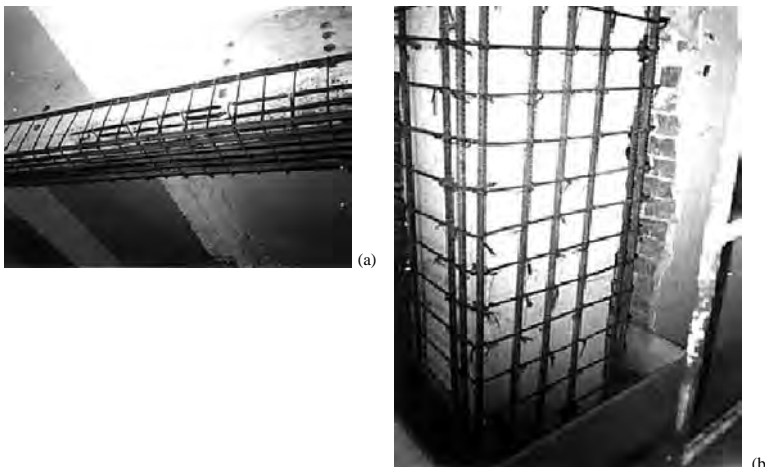
Fig. 5.11: RC strengthening of: (a) main girder; (b) column

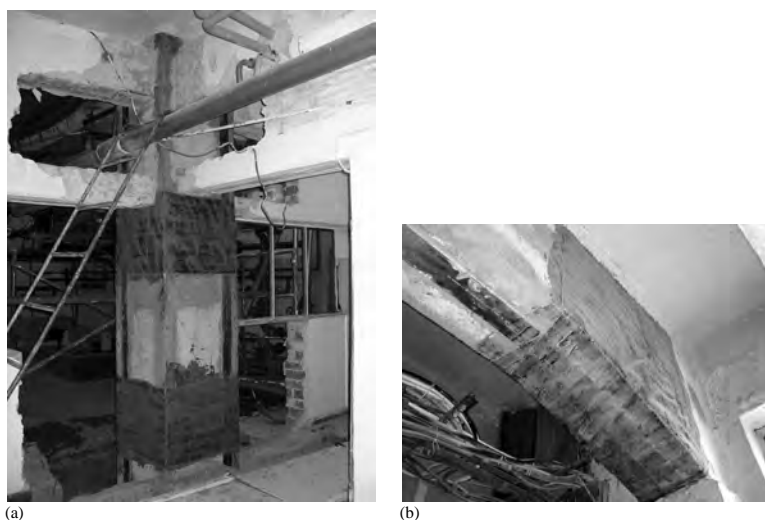
The strengthening, performed in 2003, was used for some beams and one column characterized by inadequate flexural and shear reinforcement. The strengthening solution adopted was based on carbon fibre polymer composites (CFRP) as it is illustrated in Figs. 5.12 and 5.13. The column was strengthened at the ground storey by longitudinal Sika Carbodur S1012 strips on each side of 100 mm width and 1.2 mm thickness. The strips were placed in different position in the cross section to pass by the structure node. As shear strengthening, a single layer of Sika wrap HEX 230C closed jacket was used on 1.20 m height at the ends of the column. The sheets had 600 mm width and 0.12 mm thickness. The beams were strengthened at several stories by a longitudinal Sika Carbodur S1012 strip of 100 mm width and 1.2 mm thickness. The strips were placed at the bottom side of the cross section as necessary from design. As shear strengthening, a single layer of Sika wrap HEX 230C open jacket was used on 1.20 m height at the ends of the beams. The sheets had 600 mm width and 0.12 mm thickness. CFRP material characteristics used for strengthening are $E_f = 165$ kN/mm² and $\varepsilon_{fu} = 0.017$ for longitudinal strips; $E_f = 231$ kN/mm² and $\varepsilon_{fu} = 0.017$ for transversal wraps.

Fig. 5.12: CFRP strengthening of: (a) column; (b) main girder (Units: mm)

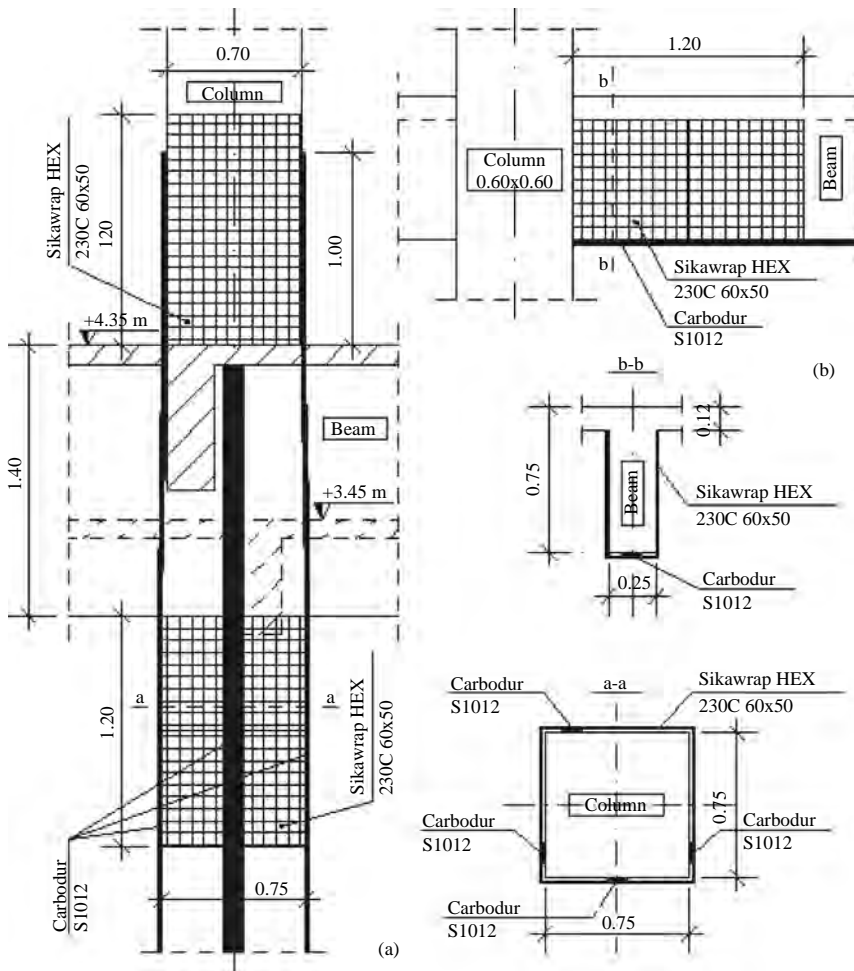
Fig. 5.13: CFRP strengthening details for: (a) column; (b) main girder (Units: m)

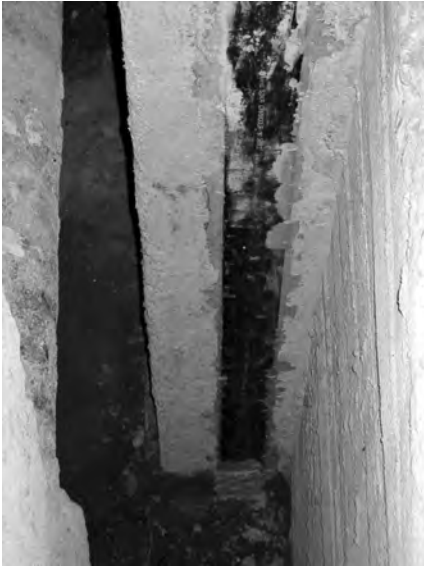
Fig. 5.18: End anchorage of longitudinal CFRP strips for column

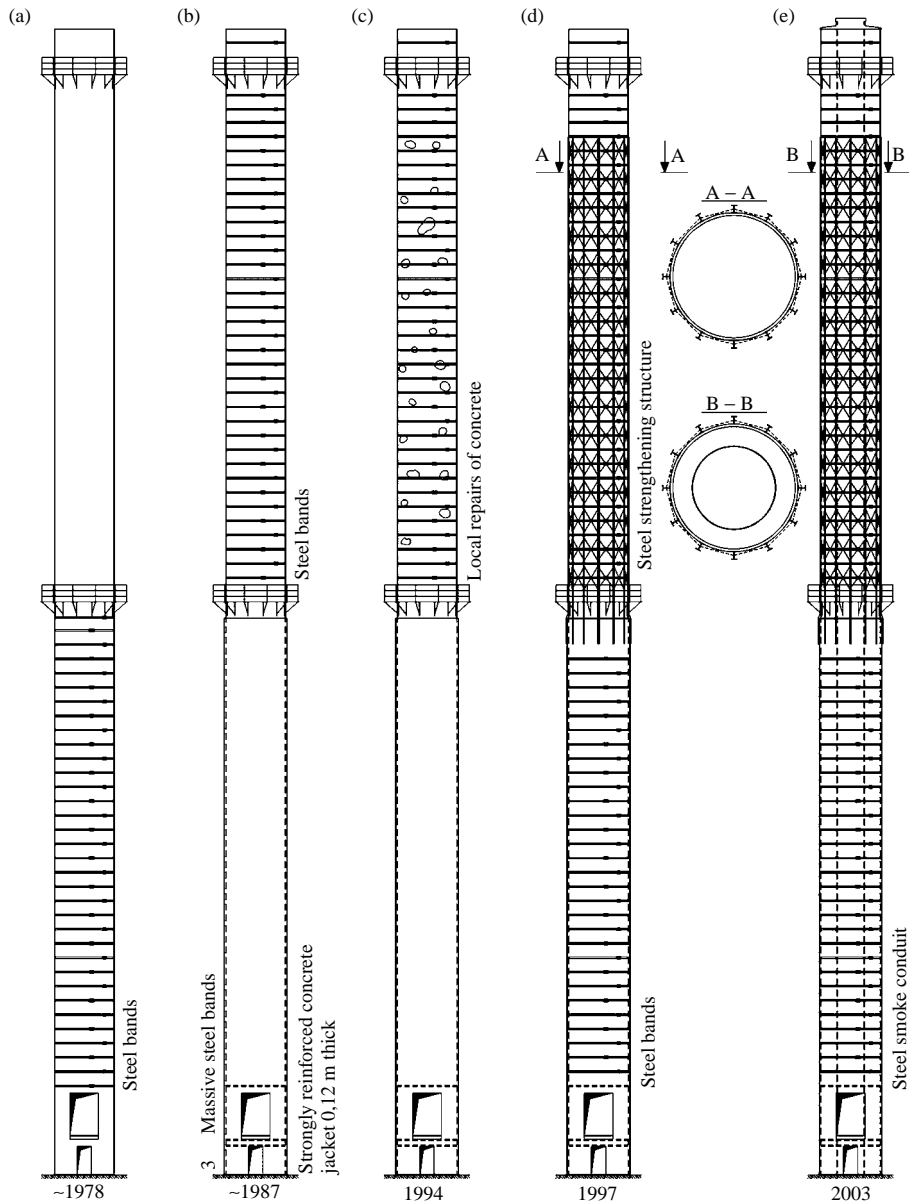
Fig. 6.2: Rehabilitation phases

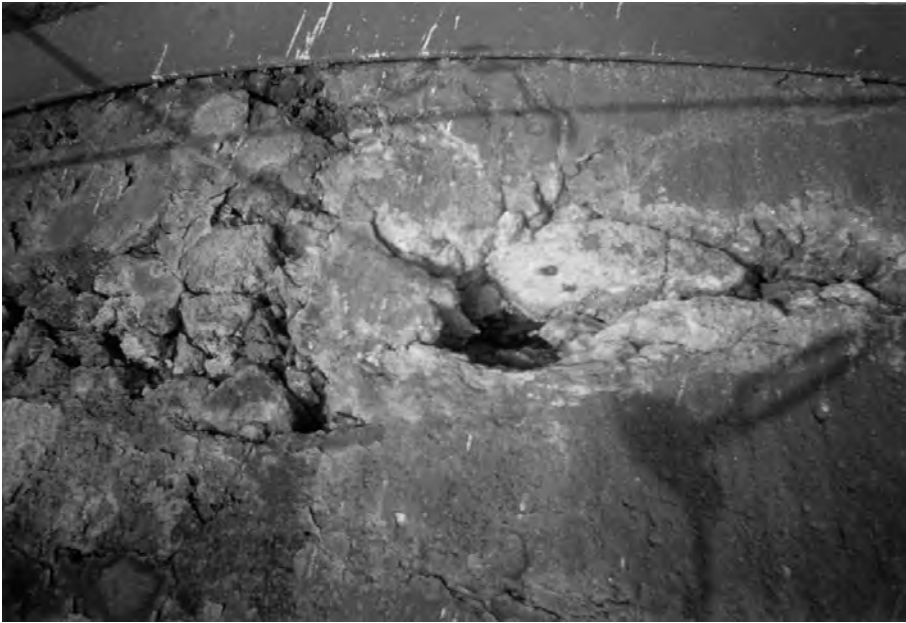
Fig. 6.3: An example of outer jacket damage

- numerous, considerably wide cracks up to 10 mm; in the past some cracks were filled with unknown bituminous substance which flowed out in a considerable amount under the influence of temperature;

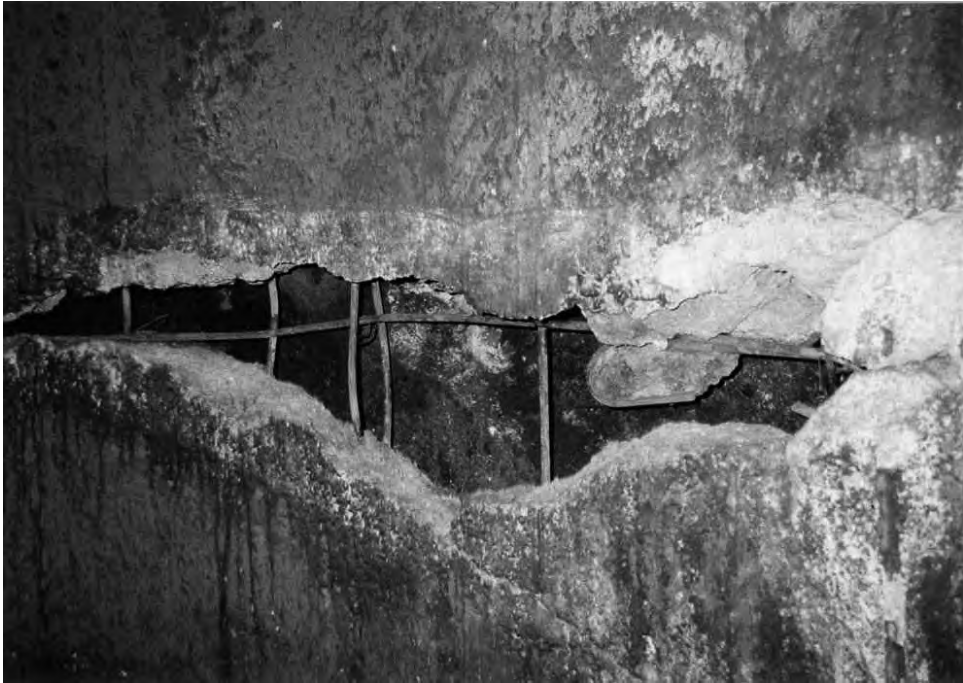
Fig. 6.4: An example of inner jacket damage

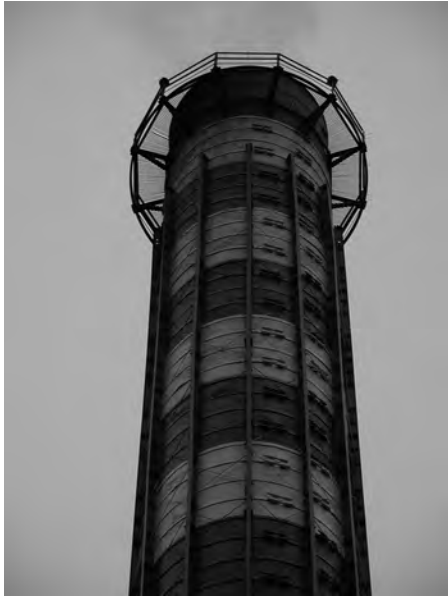
Fig. 6.5: The construction of steel strengthening of the upper part of the shaft

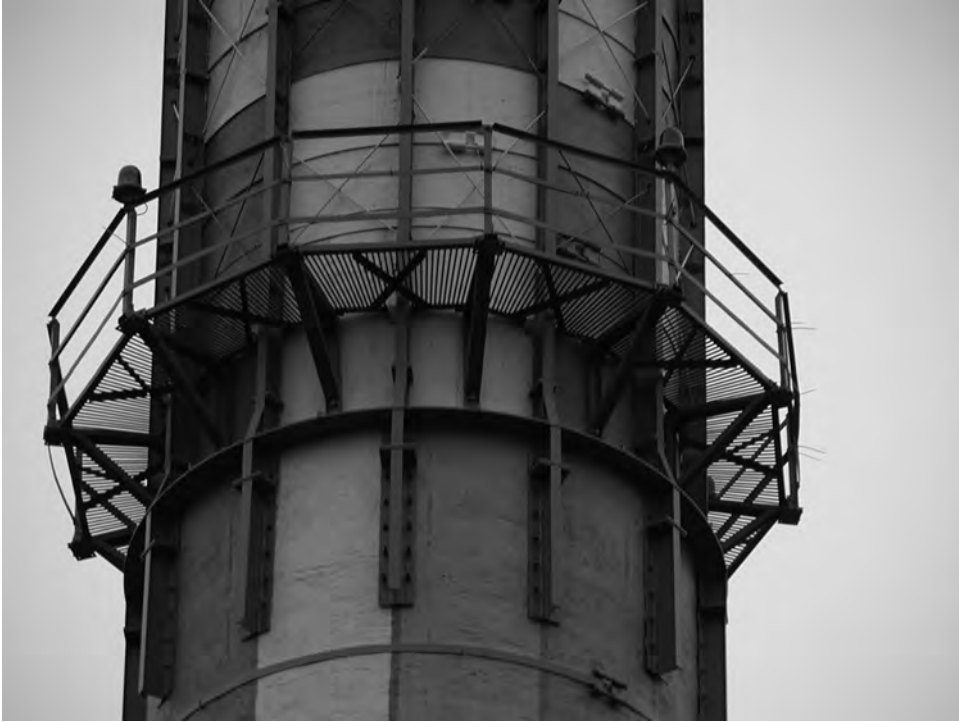
Fig. 6.6: The detail of resting the steel members on the additional RC jacket

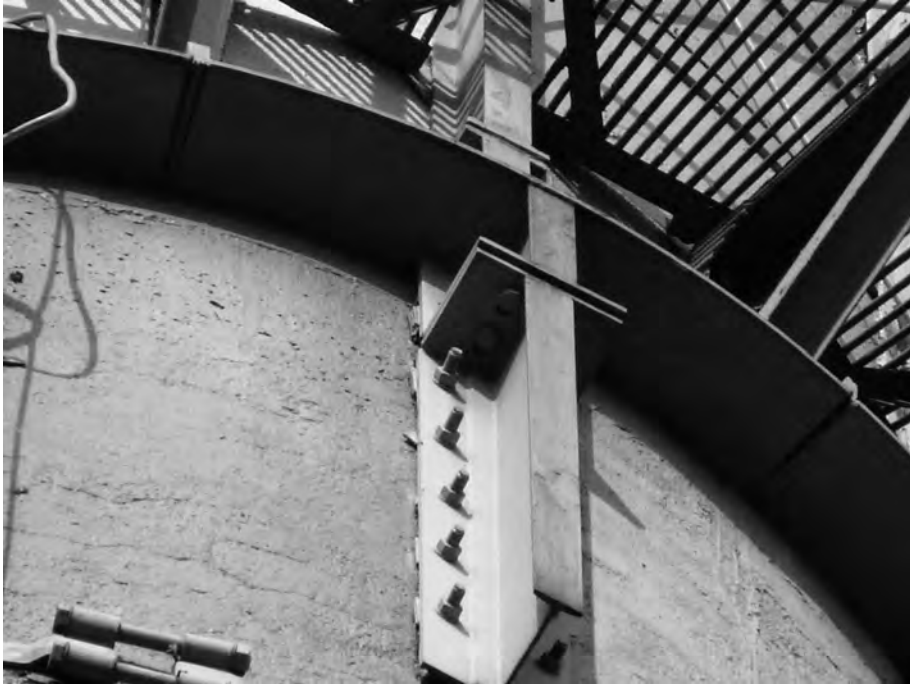
Fig. 6.7: The detail of anchoring the steel members to the outer RC jacket

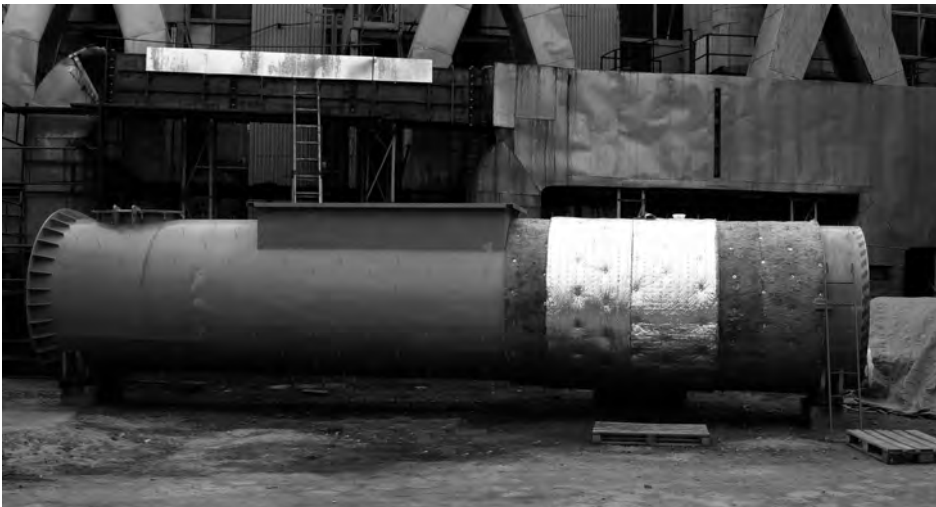
Fig. 6.10: Lower element of the smoke conduit during placing the thermal insulation

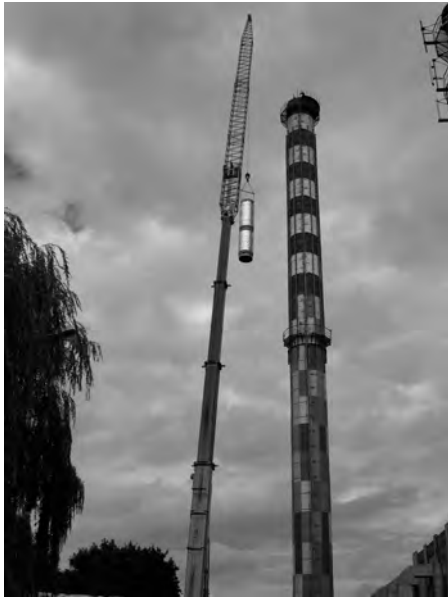
Fig. 6.11: Smoke conduit typical element installation
