Case Studies of Rehabilitation, Repair, Retrofitting, and Strengthening of Structures

Structural Engineering Documents

This monograph provides case studies of structural rehabilitation, repair, rehabilitation, strengthening, and upgrading of structures, which might be encompassed - in short - by the convenient umbrella terms “Conservation / Maintenance / Preservation / Upgrading of Existing Structures”. Other umbrella terms for the activities related to maintaining and/or improving the structural performance of existing structures include: Restoration, Structural Renovation, Remedial actions. Rehabilitation and retrofit are sometimes used also as umbrella/generic terms. Terminology is discussed in more detail in the “Introduction”.

The selected studies presented in this IABSE SED (Structural Engineering Document) cover a variety of structural types from different countries. SED 12 has been prepared as a joint activity between two IABSE Working Commissions WC3: *Concrete Structures*, and WC4 (formerly WC8): *Operation, Maintenance and Repair of Structures*.

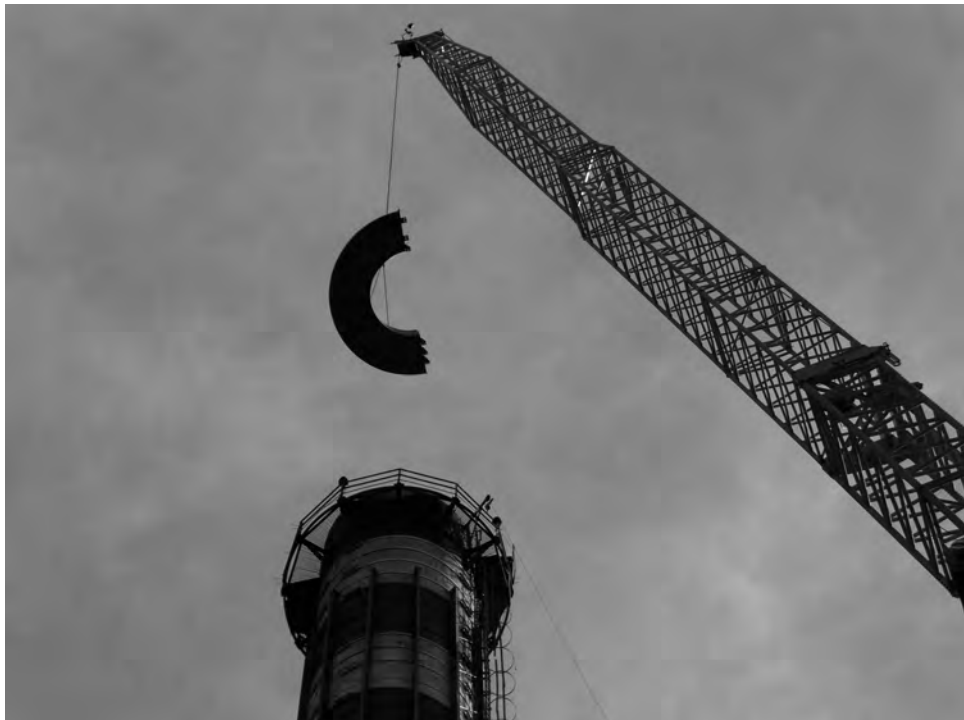
Fig. 6.12: Shaft top element installation

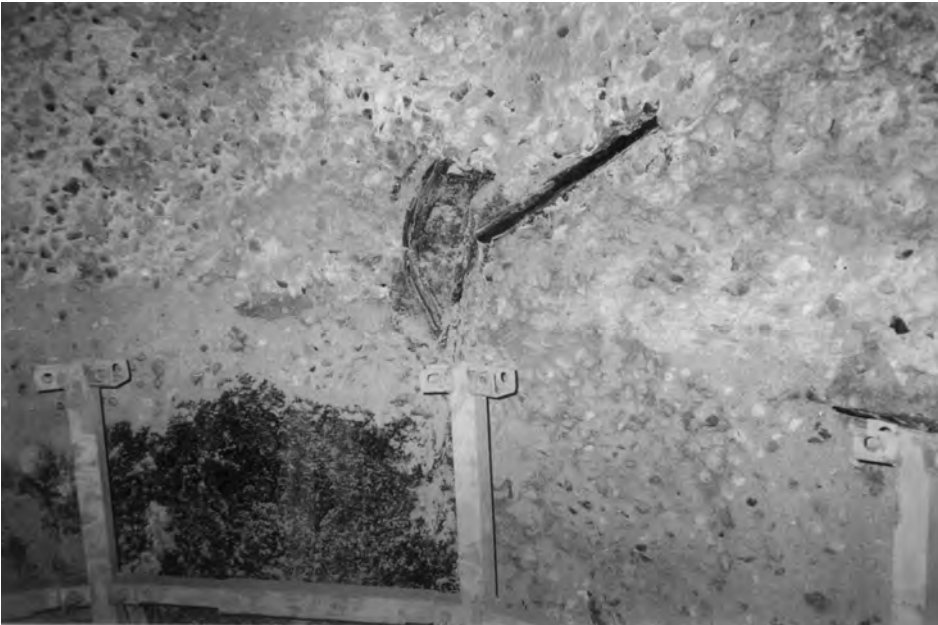
Fig. 6.14: An example of concrete surface damages on the inner surface of the carrying shaft

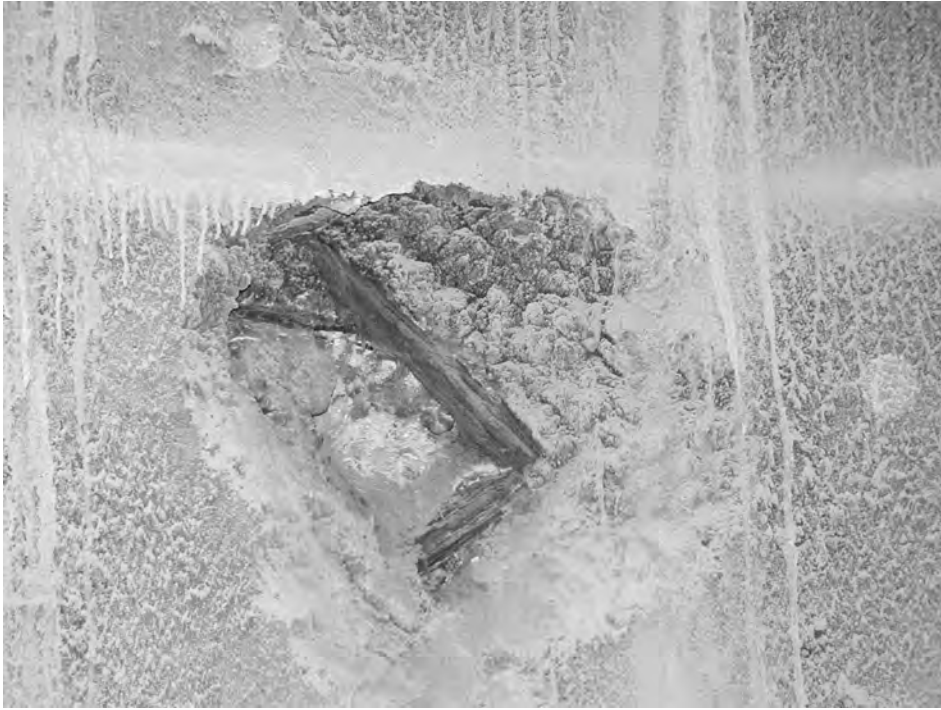
Fig. 6.15: Shaft's inner surface; an example of uncovered and corroded reinforcement

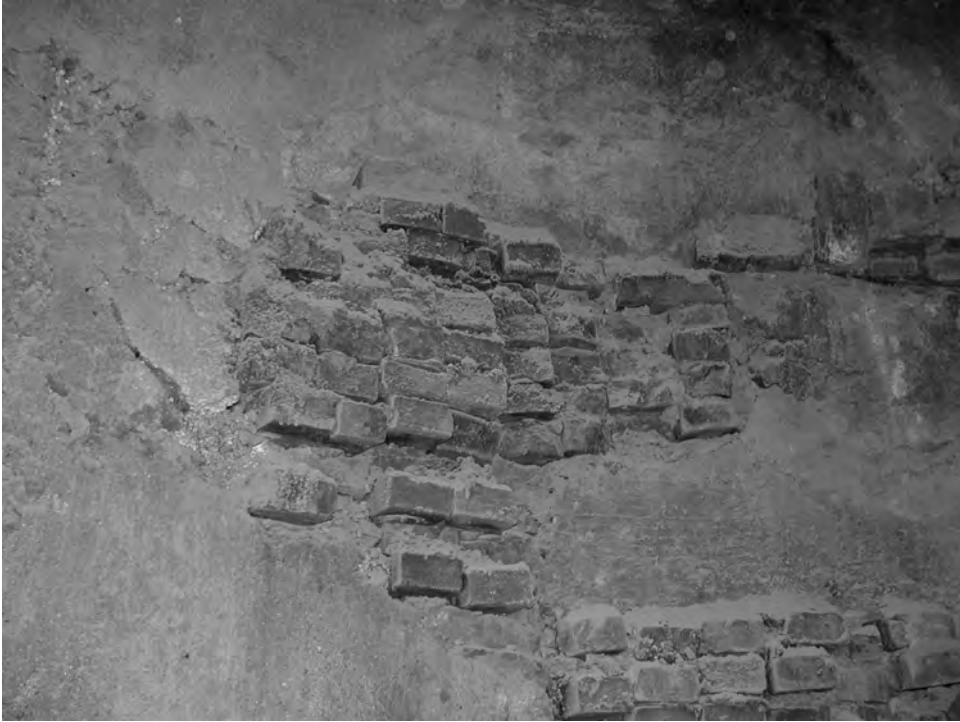
Fig. 6.16: Shaft's inner surface faults; visible void fillings with ceramic brick (outside masked with cement plaster)

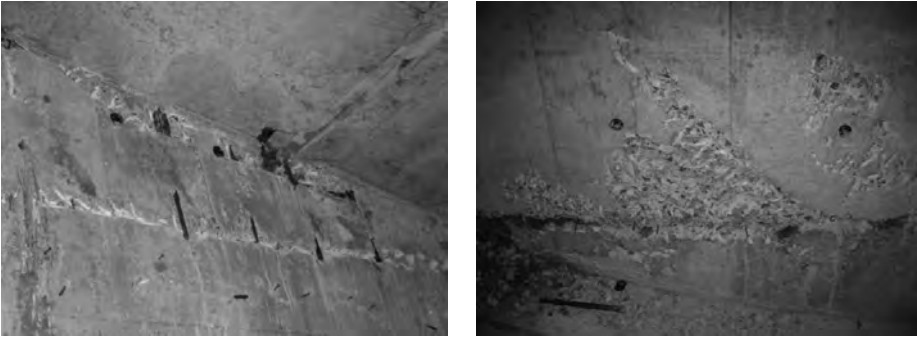
Fig. 7.7: Spalling and delamination in the existing structure

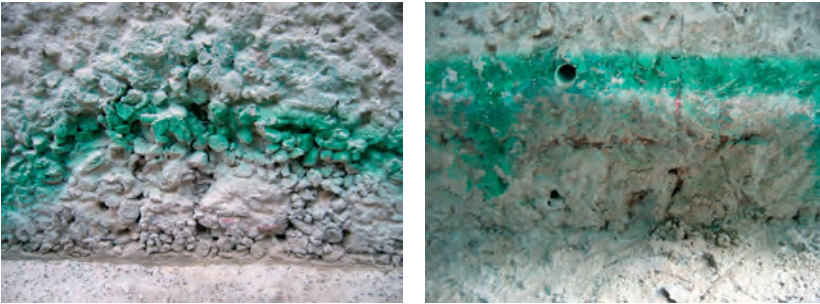
Fig. 7.8: Honeycomb in the existing structure

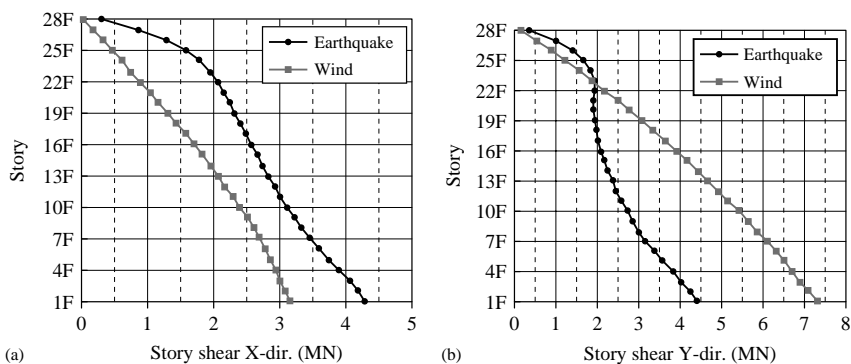
Fig. 7.10: Analysis results of story shear after rehabilitation

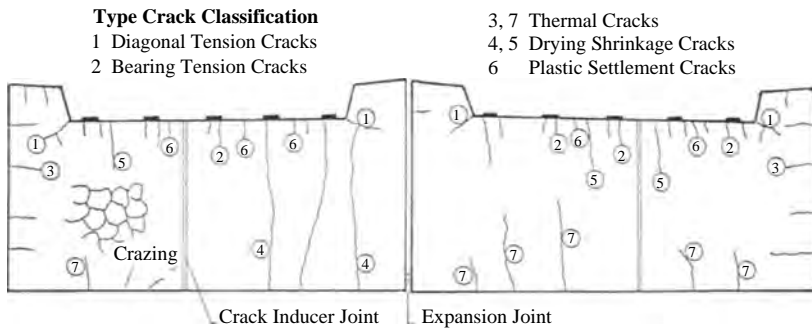
Appendix C-3b: A typical crack pattern of an abutment. (From: *Deterioration of Reinforced Concrete Structures in a Marine Environment* by D. V. Mallick, M. M. Tawil, IABSE, SEI 3, 1992)

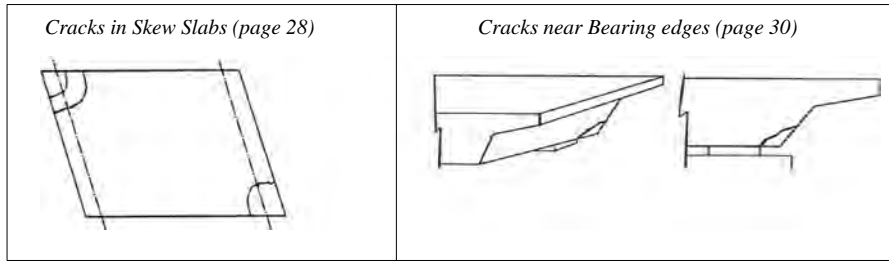
Appendix C-5a: Examples of cracking in reinforced concrete bridge deck slabs

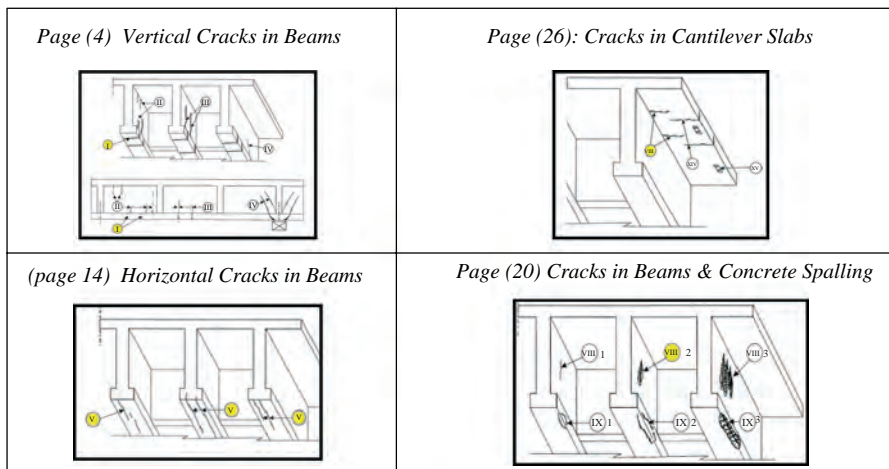
Appendix C-5b: Examples of cracking in reinforced concrete bridge beams

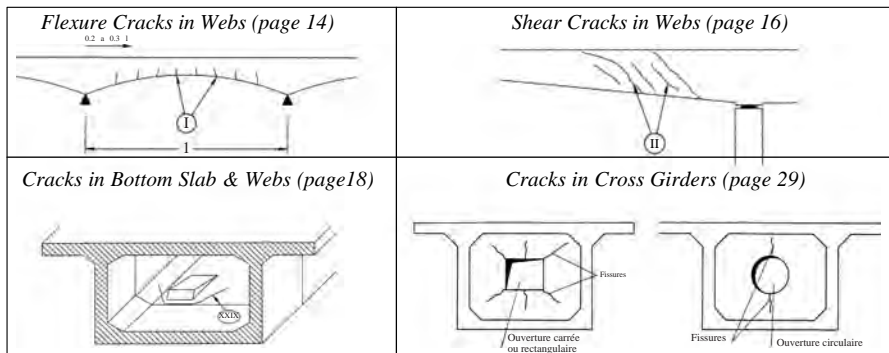
Appendix C-5c: Examples of cracking in box girder bridges

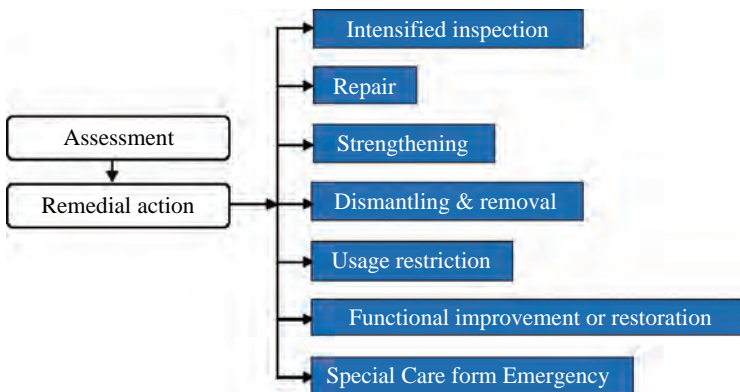
Appendix D-1: Types of remedial action

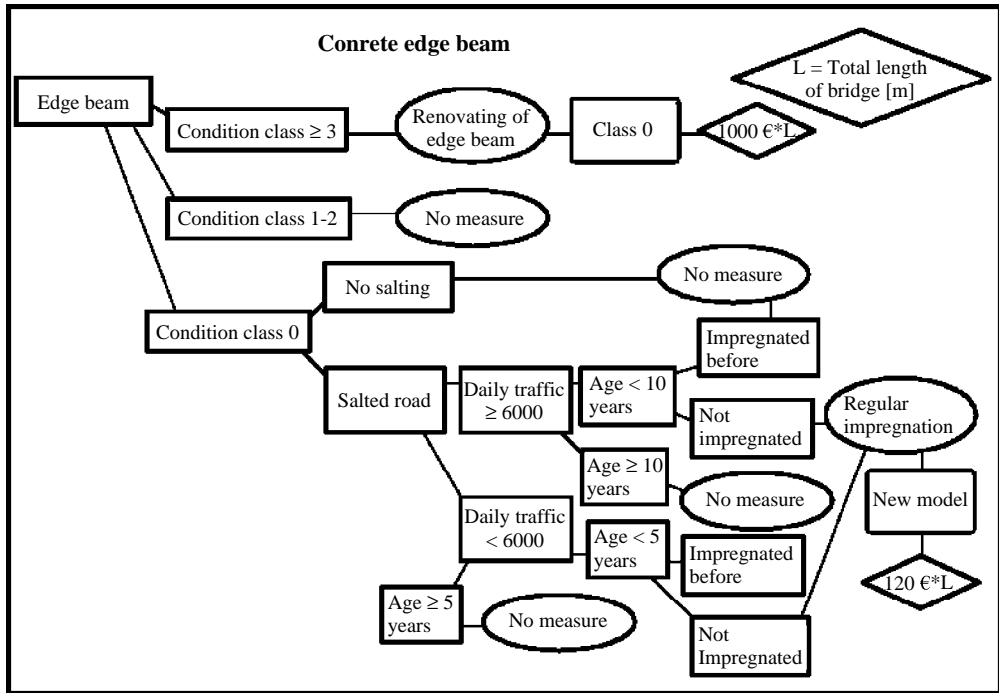
Appendix D-3: Example of decision tree for repair of bridges
 (Based on: *Anticipation of Repair Need of Bridges Based on: Visual Inspections of Finnish Bridges*, by M. Äijälä & J. Lahdensivu, IABSE Symposium, Weimar, Germany, September, 2007)
