# TIPON

Water Engineering Masterpiece of the Inca Empire

Kenneth R. Wright, P.E., L.S.

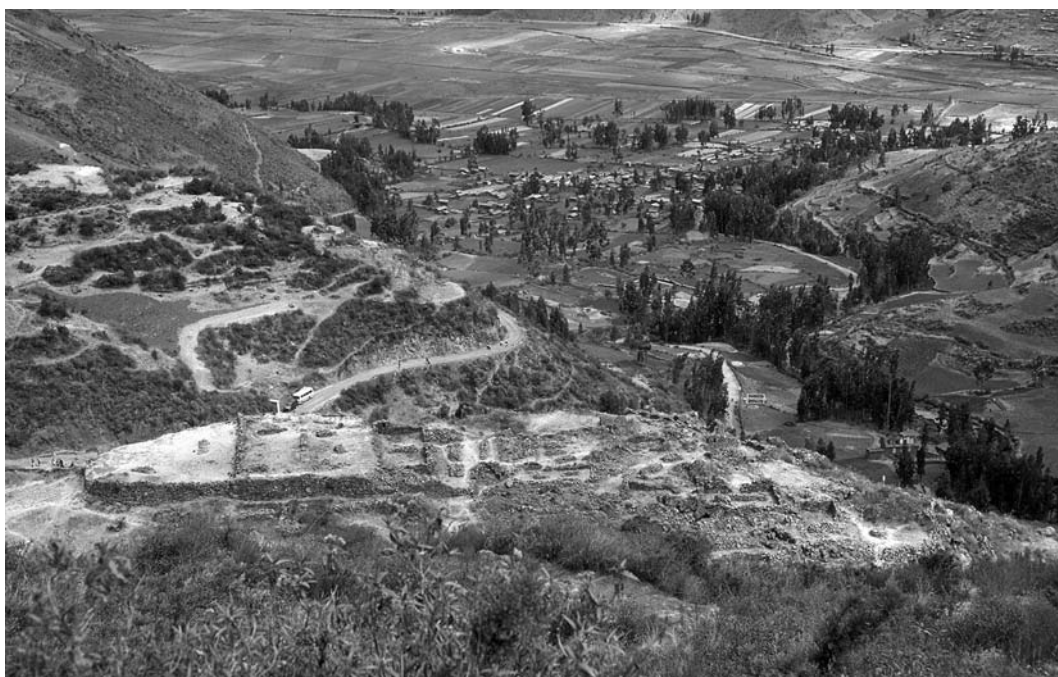
❑ Long before the Inca empire, the Wari empire ruled the lower Cusco valley. They built this huge aqueduct in the sixth century to carry water to their administrative center of Pikillacta. Archaeologists long thought the structure was a gateway because the pre-Inca or Inca later modified the Wari works to form a gate with the shaped stones in the foreground. Our surveys proved the original function was an aqueduct.

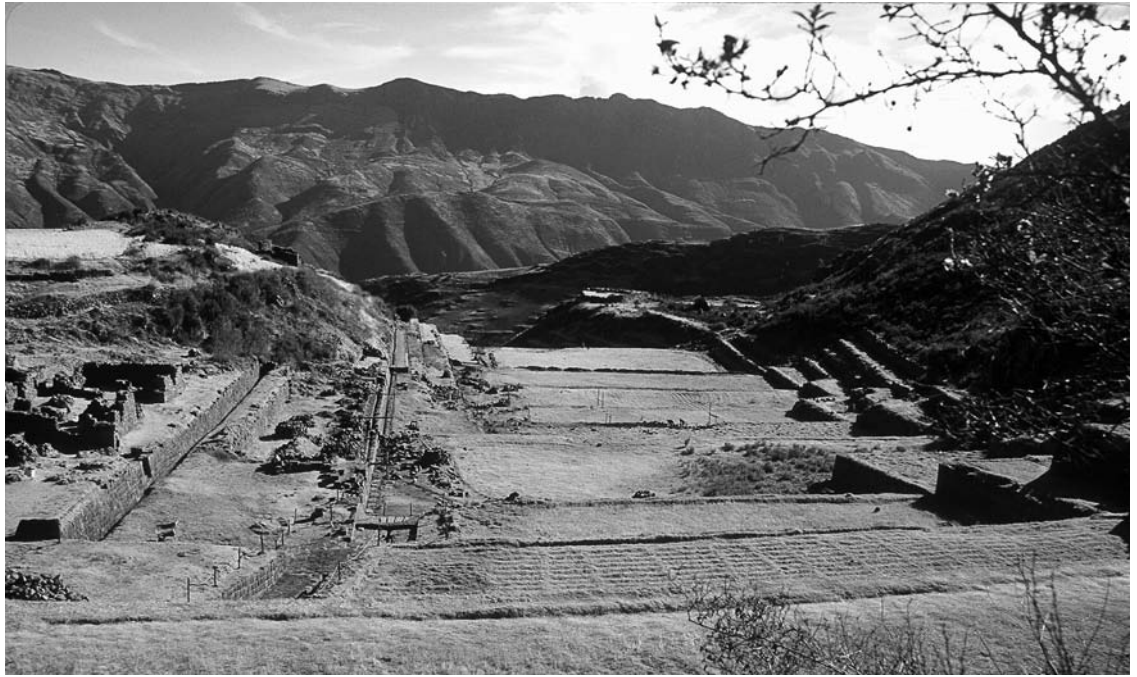
- ❖ The Rumicolca Aqueduct of about 600 CE was instrumental in the development of Pikillacta of the Wari empire. The water supply canal crossed the valley on top of the structure. The finely cut stones shown may be of pre-Inca or Inca origin when they converted the aqueduct to a huge, defensible gateway to the Cusco valley.
- Many years before the Inca occupation of Tipon, earlier people built a massive outer wall encircling Tipon that was 3.7 miles in length. Even high up on the Tipon Mountain, portions of the wall remain for modern engineers to admire.

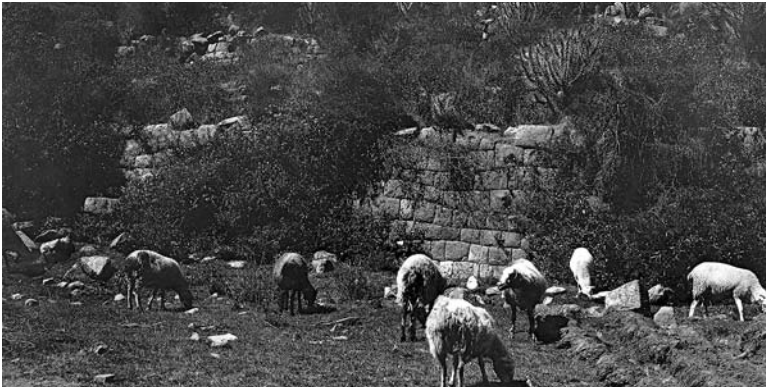
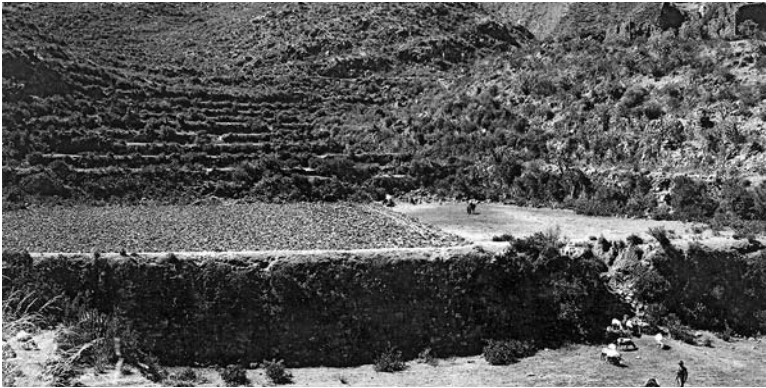
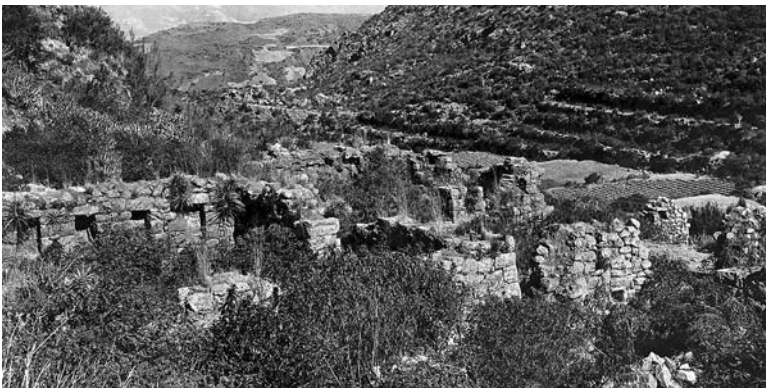
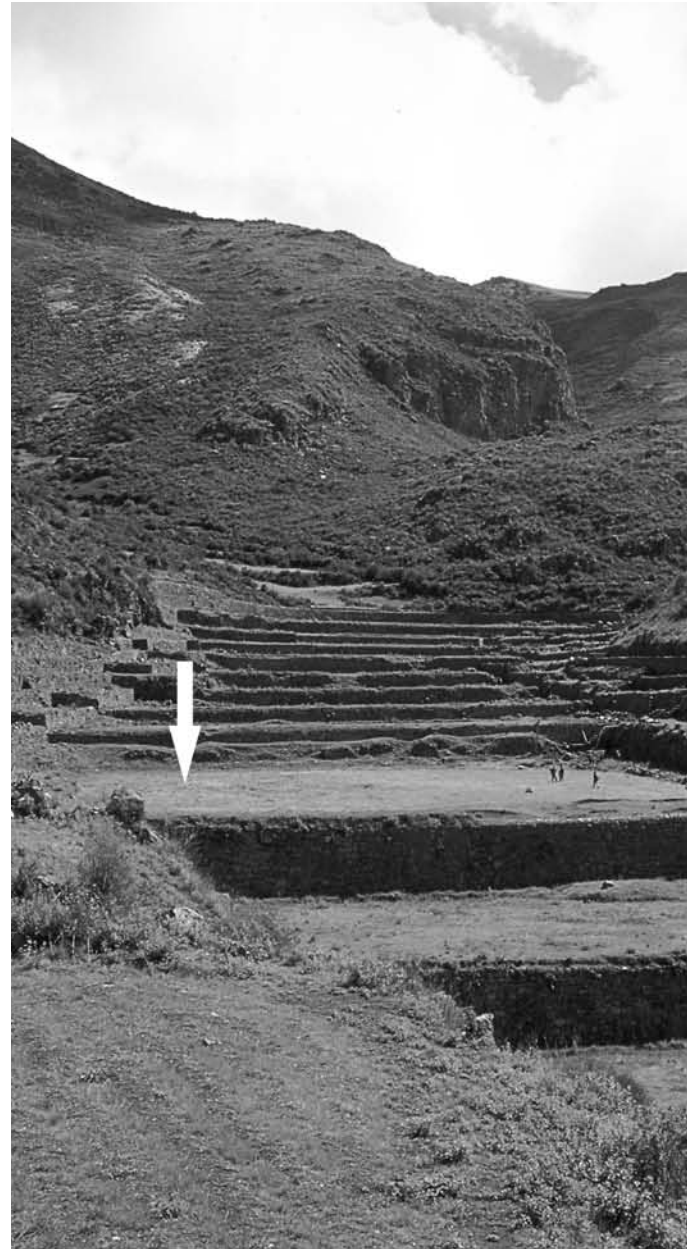
The 13 Central Terraces of Tipón are stair-stepped down the ravine from right to left, a distance of 1,300 feet. The three canal systems are labeled so that the reader can trace out the flow of water from one location to another to be able to appreciate the Inca water management genius.

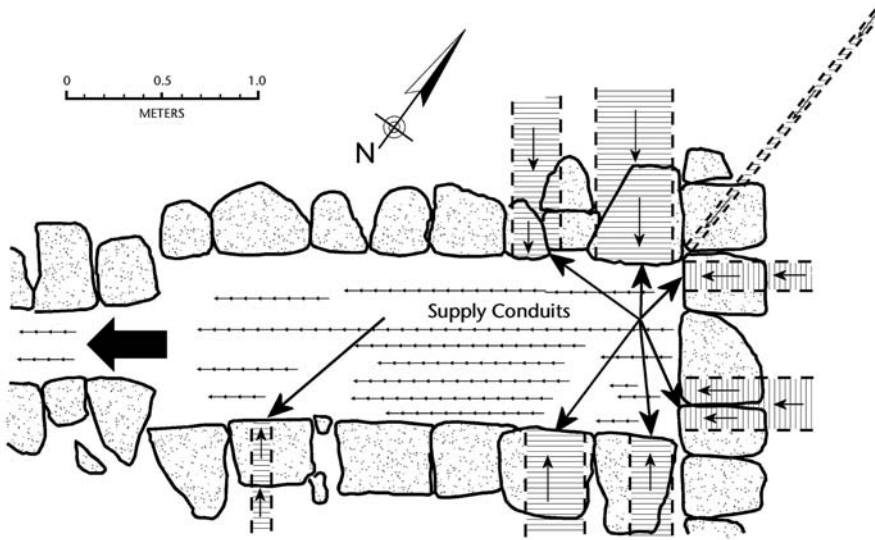
In our examination of the spring collection headworks, it became evident that the Inca engineers knew about the fundamentals of groundwater flow. They created a milestone of hydraulic engineering that was effective and efficient in

concentrating the discharge of the subsurface flow and, at the same time, allowed for an aesthetic water source structure.

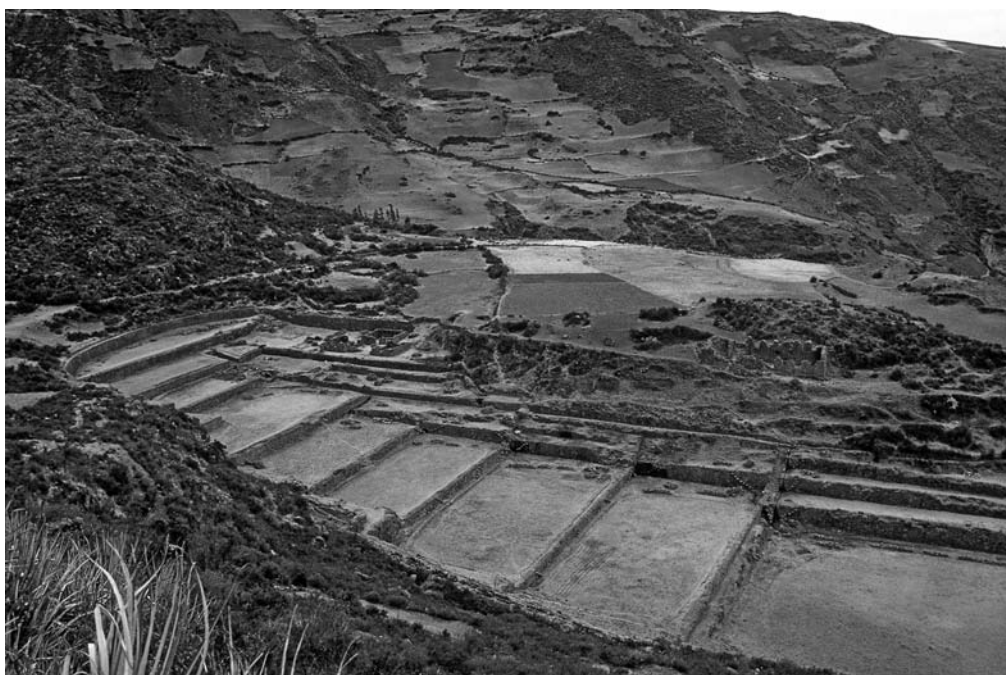
■ The Piper diagram defines the water quality of the Tipon Spring as being of high hardness with significant calcium. The chemistry tells us that the water has traveled through the limestone that underlies the volcanic rock.

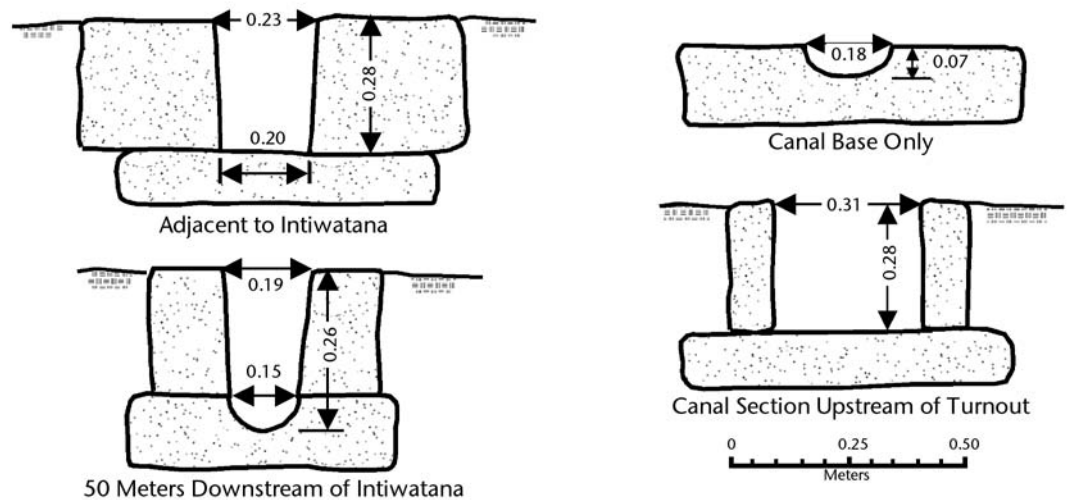
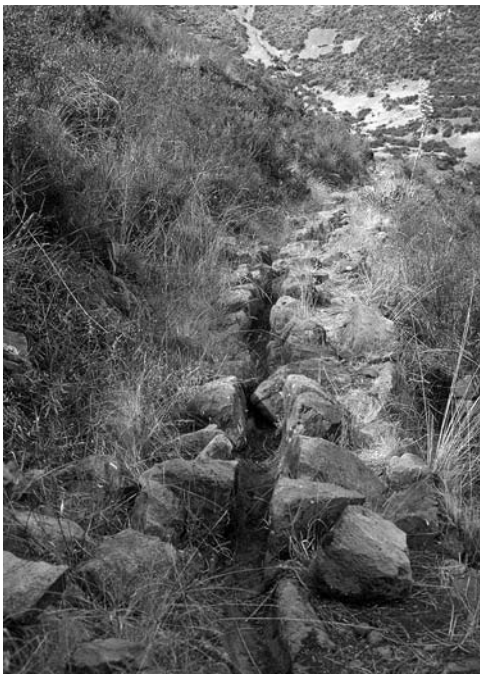
- ❖ Section 4 of the restored main canal has a wide range of slopes, but a relatively constant cross-sectional area of 0.65 square foot. Its theoretical capacity at 30 percent slope ranges up to 10 cubic feet per second; however, it would not have carried more than about one-third of that amount.

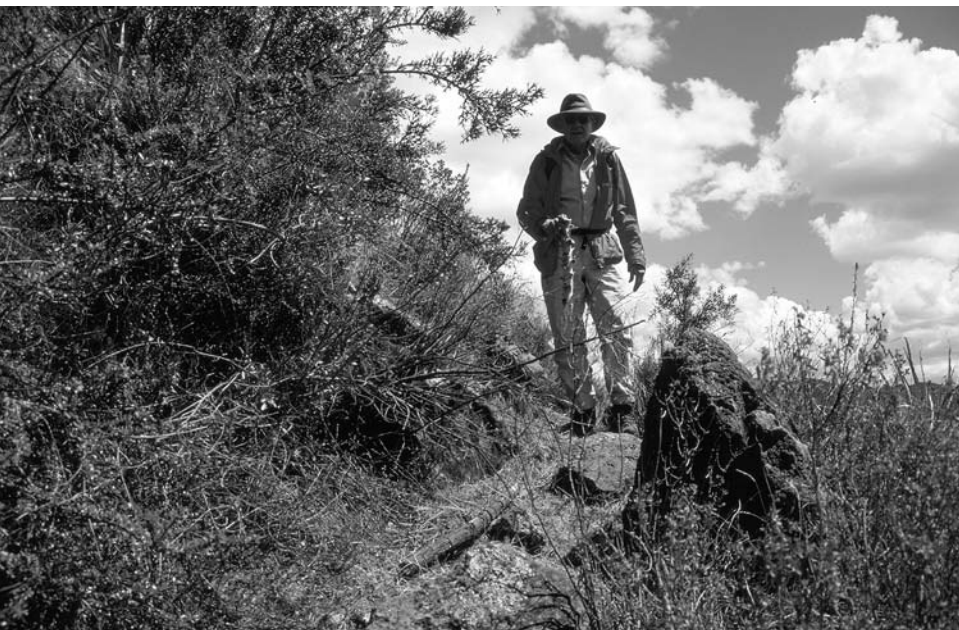
■ Portions of the remains of the original Inca main canal are in good condition. The method of construction in Section 5 of the canal was consistent though different from that for the upstream sections.

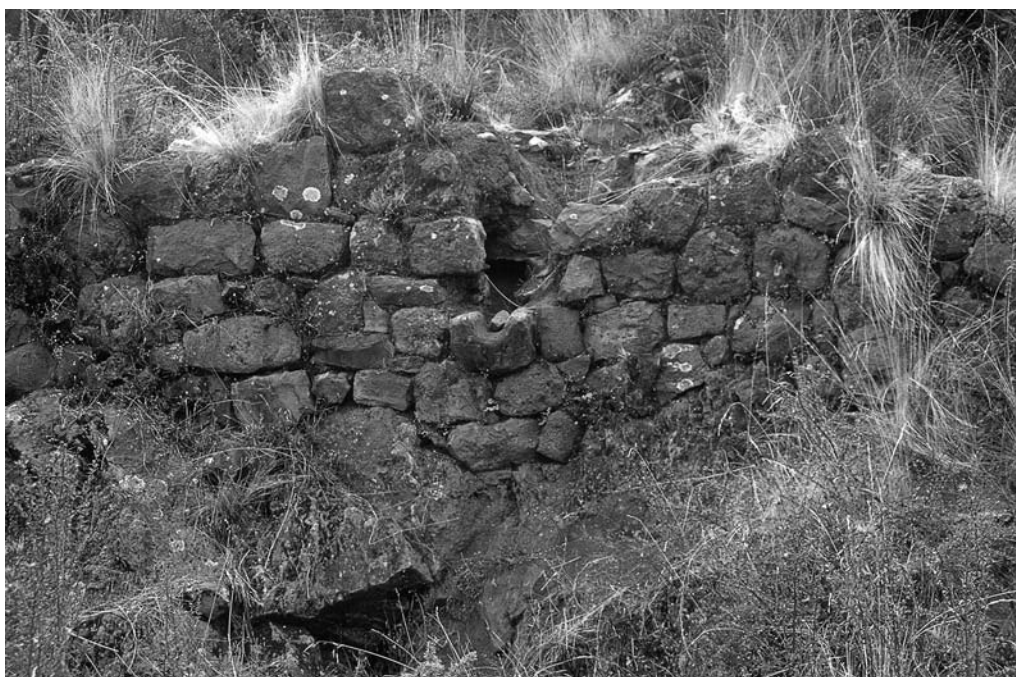
❑ Most canal bends or abrupt changes in canal direction were constructed by the Inca to avoid hydraulic problems. The canal bank stones are missing in the foreground and the carved bottom stones illustrate the design procedure used.

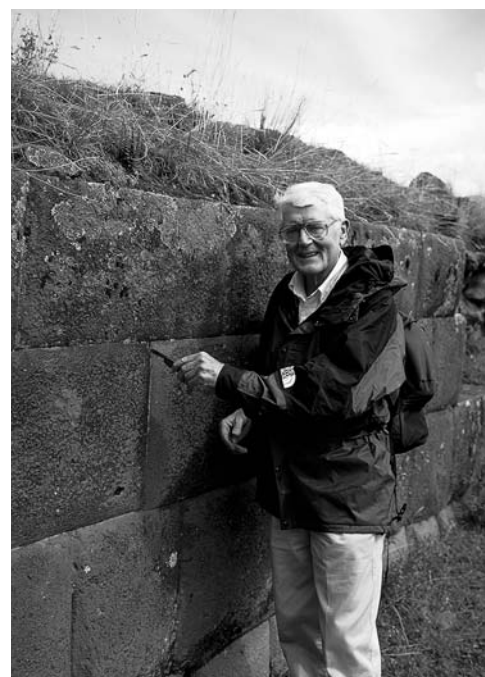
- ❖ Stonework of two of the many niches in the Ceremonial Plaza shows the high standard of care utilized in this special structure. The measurements shown are expressed in meters.

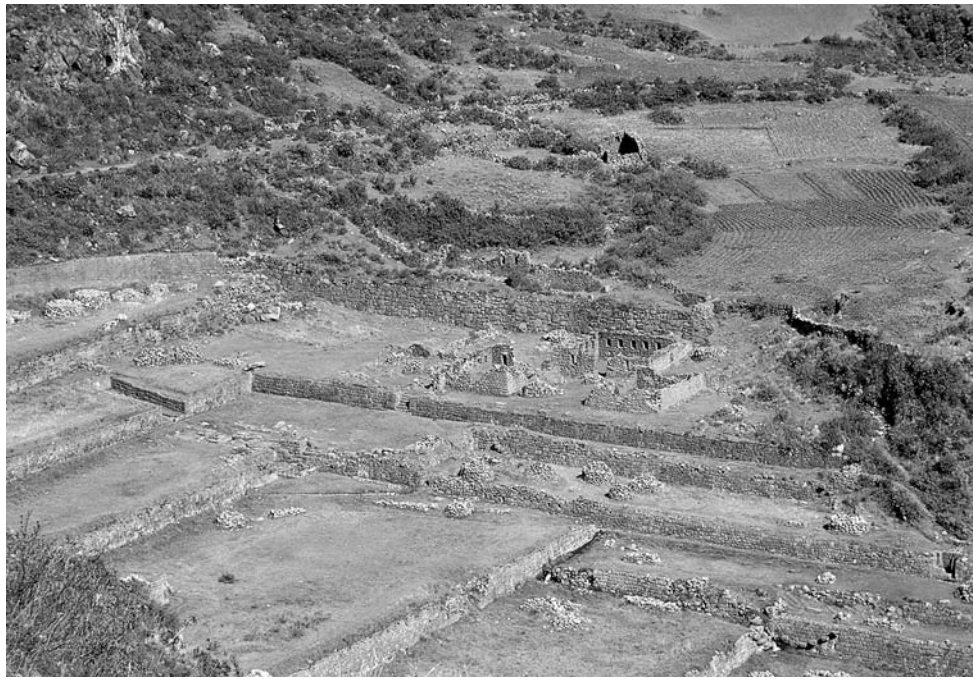
- ❖ Remains of a canal in the Ceremonial Plaza illustrate the important function of water in carrying out the original purpose of this building.
- ❖ A water delivery stone for the Ceremonial Plaza is shaped with a channel that is 4 inches deep and 6.7 inches wide. The resulting jet of water fell into a stone basin and was suitable for filling water bottles.
